Date of Report: 24 February, 2026 9:33pm EST

1314 Norwood Avenue Chelsey

Inspection Brief

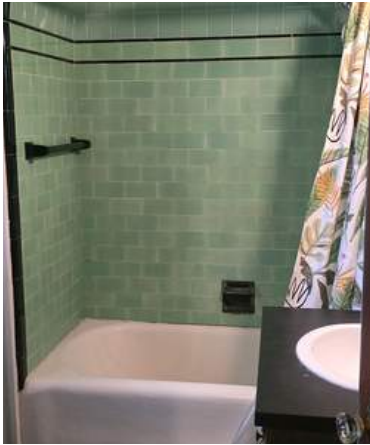
Wall Tile (Condition Notes)

Fair

No hazardous cracks, chips, or loose tiles are present. The tile shows minor cosmetic aging but presents a stable surface overall.

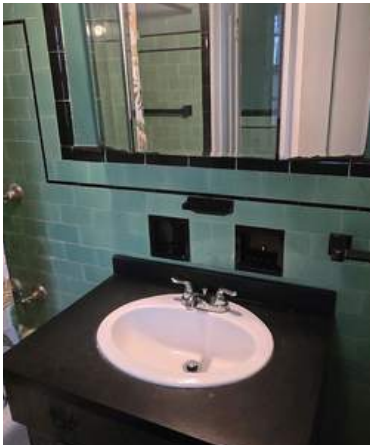
Vanity Cabinet (Key Disclosures)

Fair

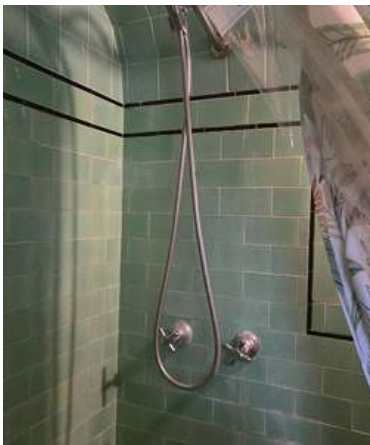
Shower Surround (Key Disclosures)

Fair

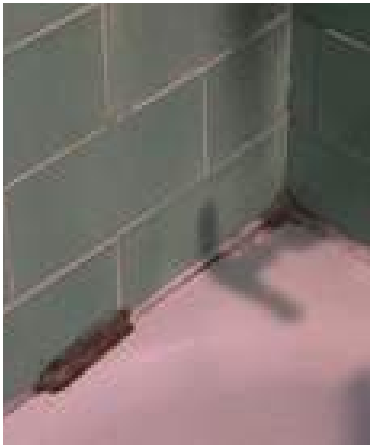
Ceramic Tile Wall (Key Disclosures)

Poor

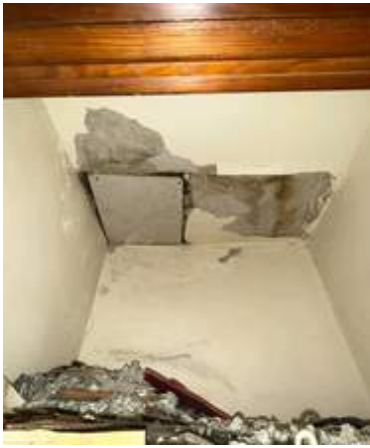
Ceiling (Key Disclosures)

Poor

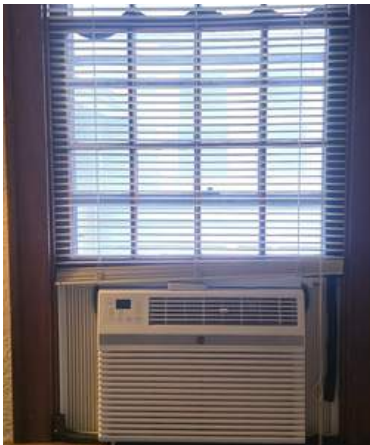
Window (Key Disclosures)

Poor

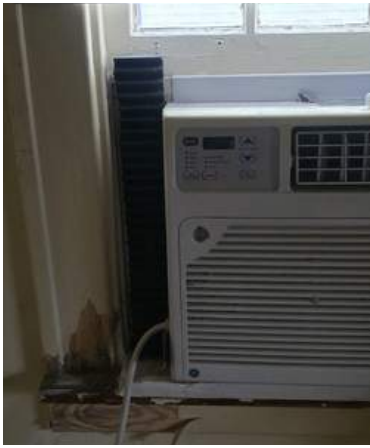
Window Frame (Key Disclosures)

Poor

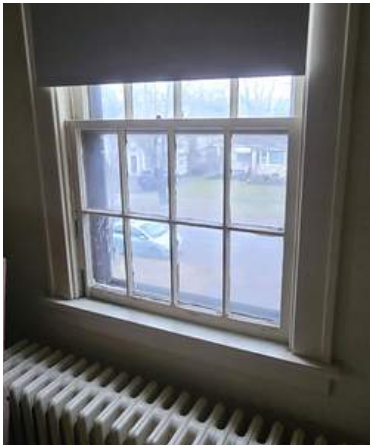
Window (Key Disclosures)

Poor

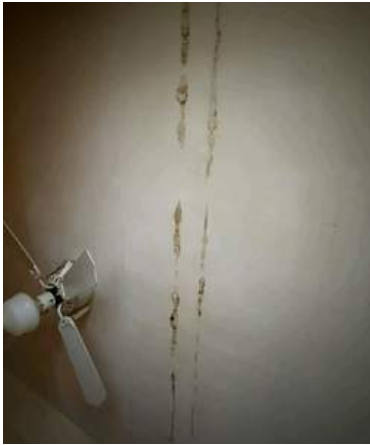
Ceiling (Key Disclosures)

Poor

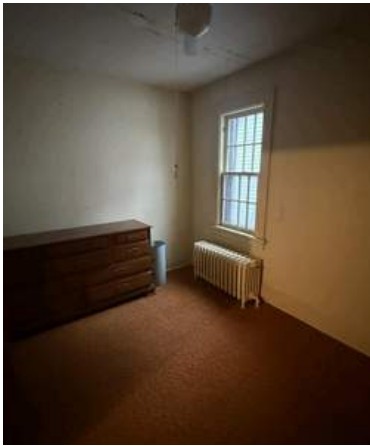
Ceiling (Key Disclosures)

Poor

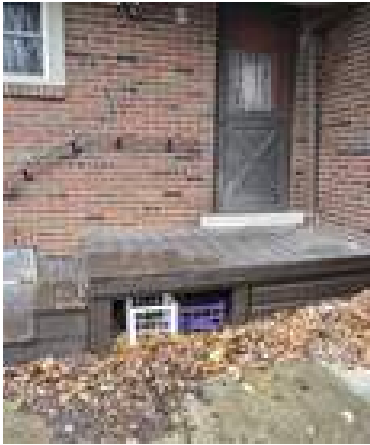
Wood Deck and Steps (Key Disclosures)

Poor

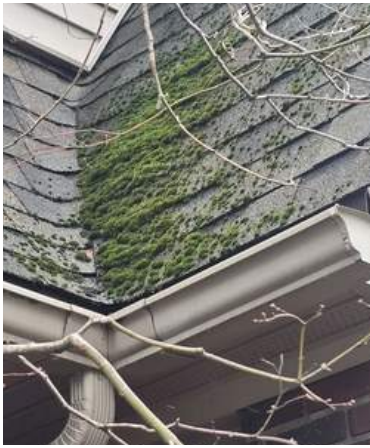
Asphalt Shingle Roof (Key Disclosures)

Poor

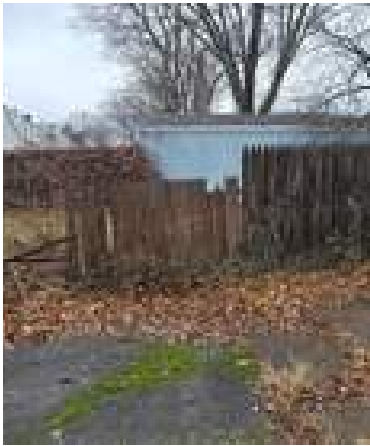
Wood Fence (Key Disclosures)

Poor

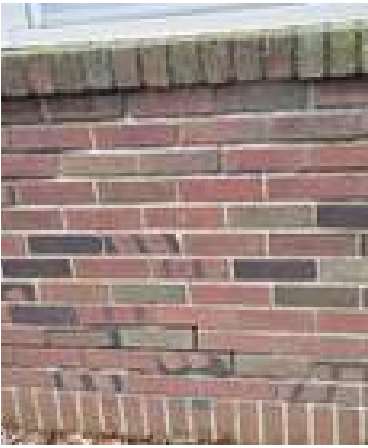
Exterior Brick Wall (Key Disclosures)

Poor

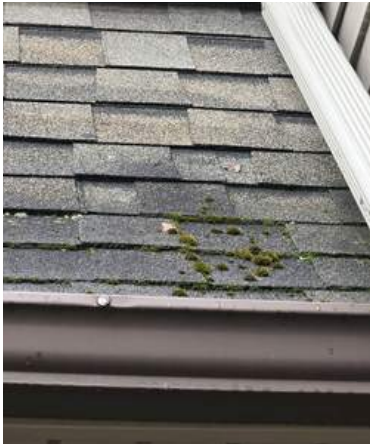
Roof Shingles (Key Disclosures)

Poor

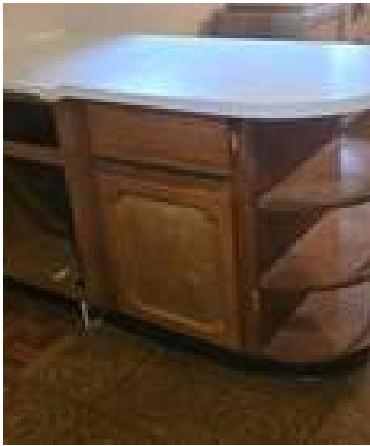
Base Cabinet Unit (Key Disclosures)

Poor

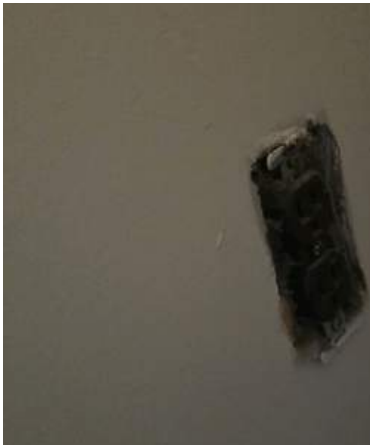
Electrical Outlet (Key Disclosures)

Poor

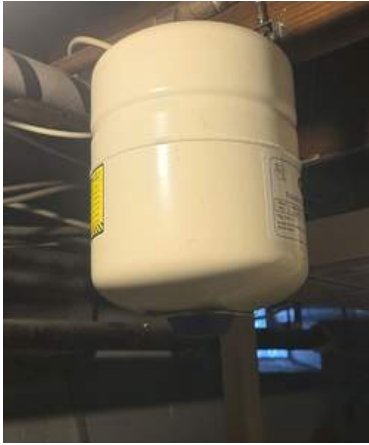
Expansion Tank (Key Disclosures)

Poor

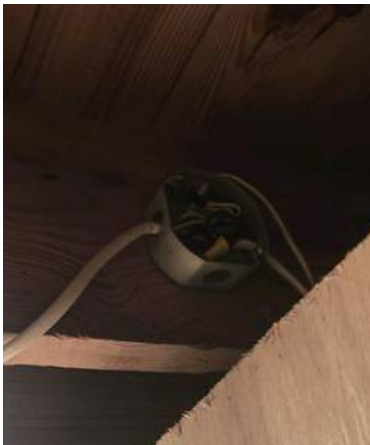
Electrical Junction Box (Key Disclosures)

Poor

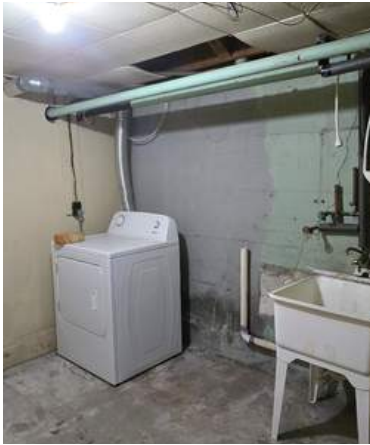
Drop Ceiling (Key Disclosures)

Poor

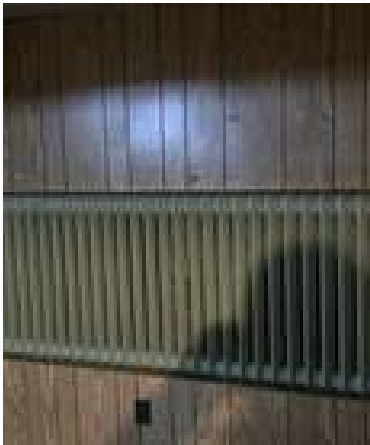
Wall-Mounted Radiator (Key Disclosures)

Poor

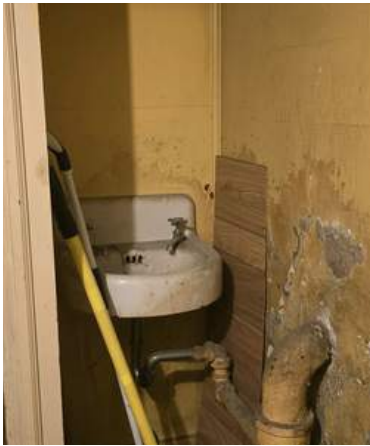
Wall-Mounted Sink (Key Disclosures)

Poor
