Date of Report: 24 February, 2026 9:32pm EST

PropertyManager - MidTenancy

2965 Jerauld Ave

Betsy House

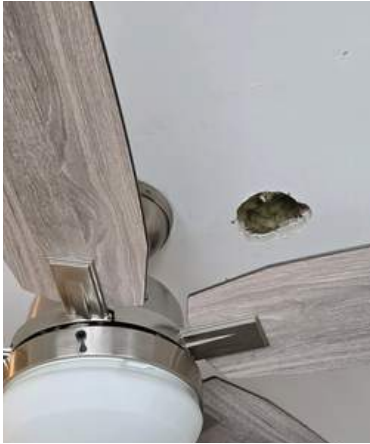
### Ceiling Surface

Poor

The painted drywall ceiling has a visible, irregular hole that exposes insulation or wall cavity material. No water stains or paint damage are seen near the defect. This is a priority repair due to exposure risks.

Material: Painted drywall  
Damage: High

**Next Action:** Schedule immediate patch and restoration of the damaged ceiling to restore integrity and prevent further risks; continue monitoring all surfaces for routine maintenance needs.

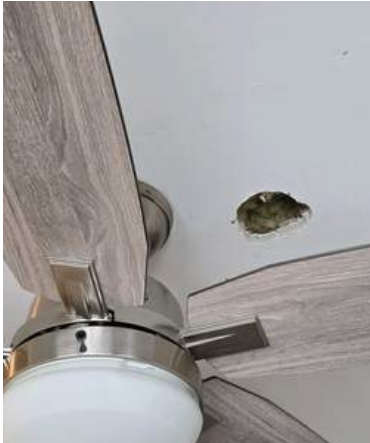
## Ceiling drywall

Poor

Ceiling drywall has a large hole next to the fan, exposing insulation. No visible staining or water damage nearby. This open area clearly requires prompt repair.

Damage: High

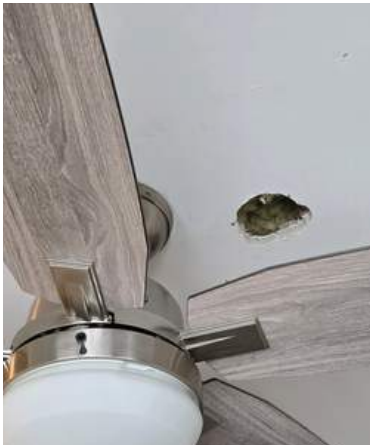
## Ceiling (drywall/plaster)

Poor

Ceiling material has a hole exposing insulation by the fan; the rest appears intact with no stains. Localized breach in enclosure needs repair.

- Safety/Compliance: Local breach not immediately hazardous but requires correction.
- Asset Impact: Must be closed to prevent greater deterioration.

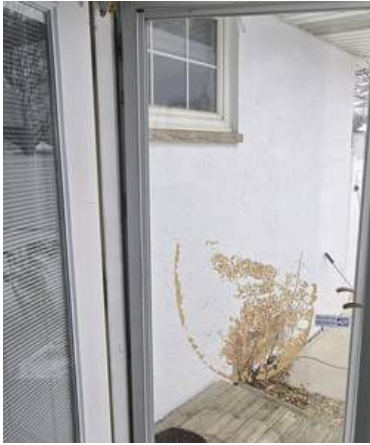
## Storm Door

- Safety/Compliance: The compromised storm door presents a moderate safety and entry security concern; all other structural risks are minimal.
- Asset Impact: Delay in storm door repair could worsen entry deterioration. Addressing minor cracks and plant overgrowth now will help prevent future foundation or HVAC concerns.

Poor

**Next Action:** Arrange immediate storm door repair. Remove nearby plant growth, and periodically inspect stucco and foundation for signs of change.

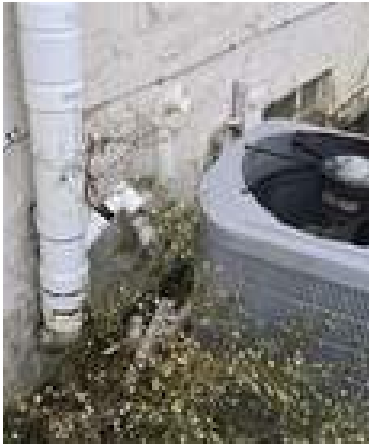
## Exterior HVAC condenser unit

Fair

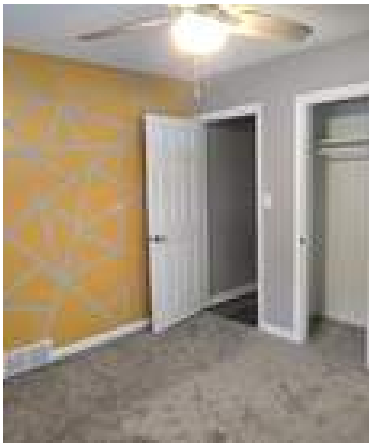
### Accent wall

Fair

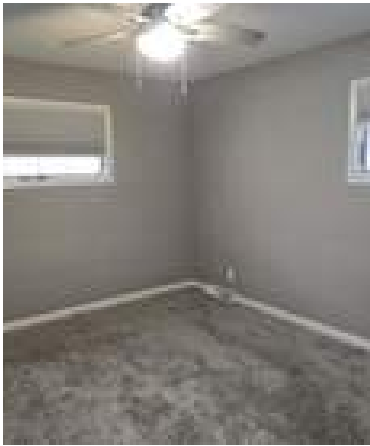
### Carpeted floor

Fair

**Next Action:** Schedule for regular deep cleaning and monitor for additional wear.

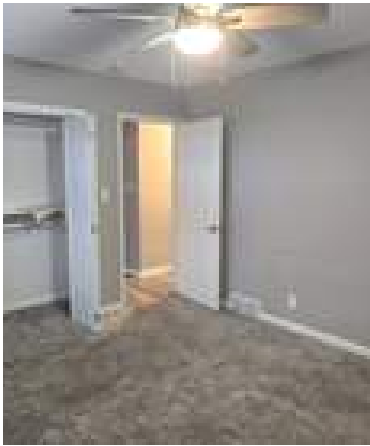
### Carpeted floor

Fair

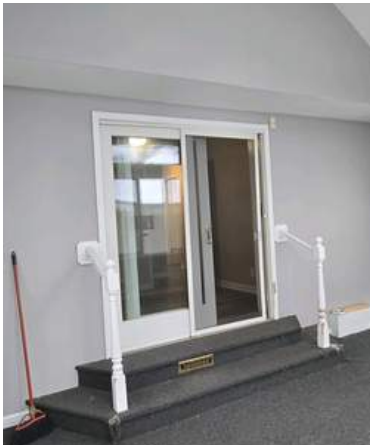
## Carpeted Floor

Fair

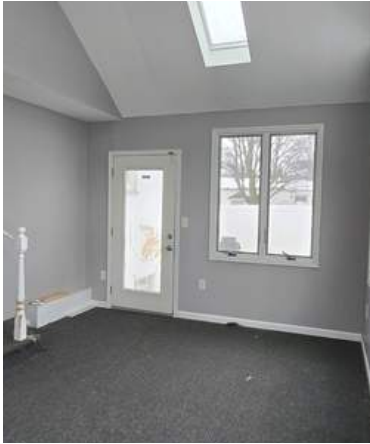
## Carpet flooring

Fair

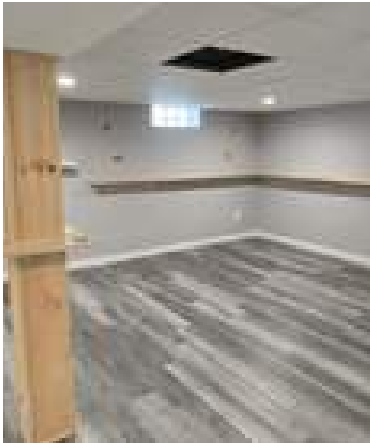
## Drop ceiling

- **Safety/Compliance:** Ceiling and utility area openings reduce code/life safety protection.
- **Asset Impact:** If not resolved, repairs may become more complex or costly and increase insurance or citation risks.

Poor

Material: Acoustic tile

Damage: Medium

**Next Action:** Schedule ceiling tile replacement and complete enclosure finishing. Confirm compliance after repairs.
