Date of Report
13 October, 2025

PROPERTY INFORMATION

8113 Frontier Ave. Niagara Falls, NY 14304

INSPECTION BRIEF

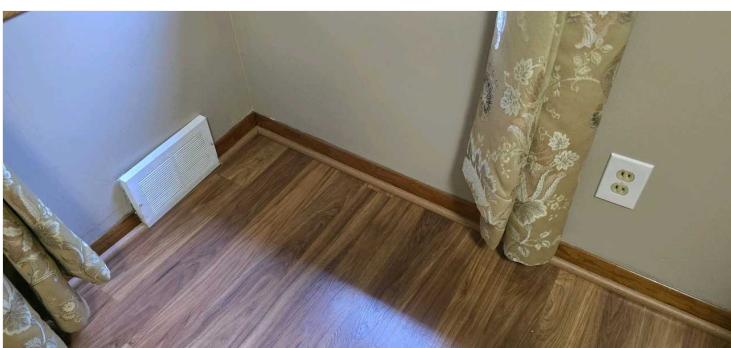
Wall Vent Register/grille

Metal wall-mounted vent cover near floor shows visible misalignment with a noticeable gap along the right edge; no fastener is visible on the right side and the cover does not sit flush to the wall. This is a priority condition note to secure/realign the cover to ensure stability and prevent detachment.

Material: Painted metal Damage: Medium

Safety Risk: Low Priority: Recommended

Asset Impact: Secure promptly to avoid future repair cost.

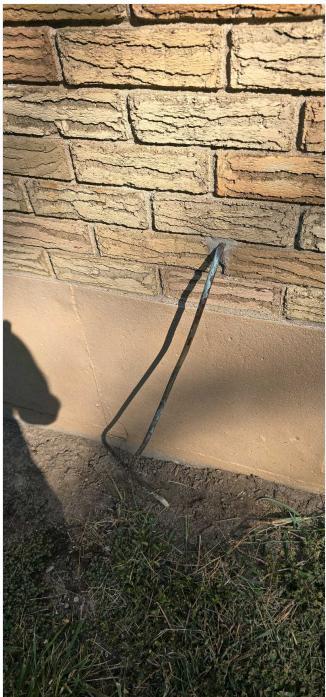
Exposed Exterior Cable/wire At Wall

Material: metal wire/cable **Damage:** Medium

Safety Risk: Moderate **Priority:** Recommended

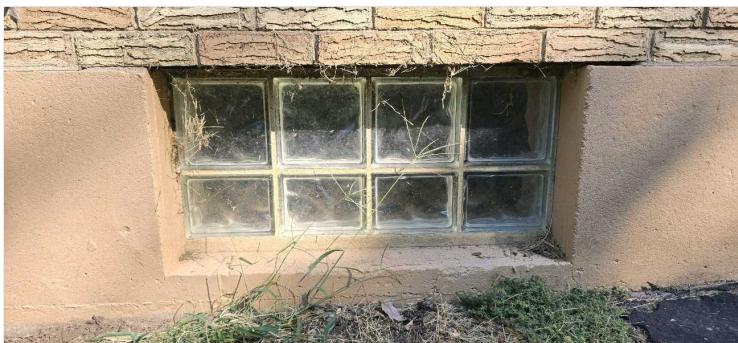
Glass Block Window Assembly YELLOW

Fixed glass-block window set in a foundation opening; all visible blocks intact without visible cracks; exterior surfaces have accumulated dust and plant fragments on the face; cleaning recommended for clear inspection and presentation.

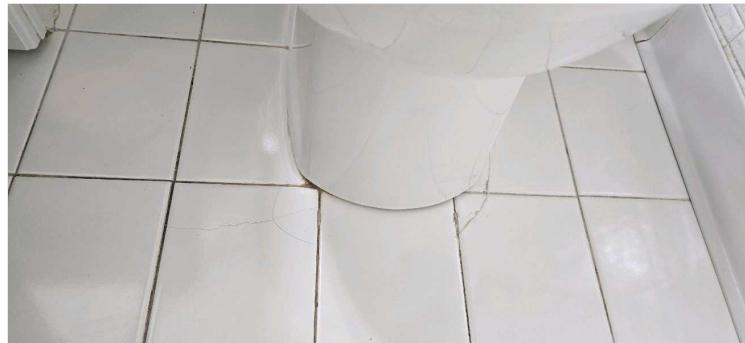
Ceramic Floor Tile Near Toilet

ORANGE

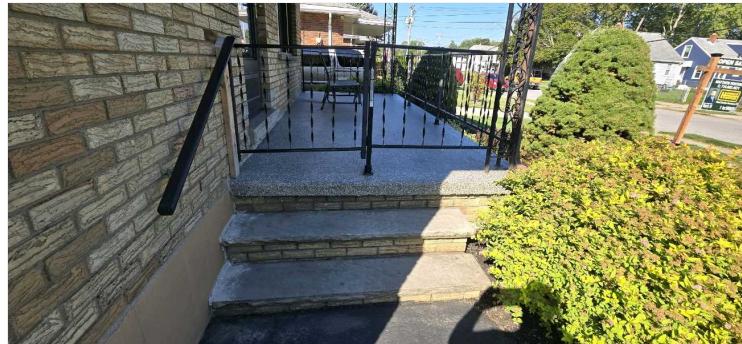
Exterior Concrete Steps

YELLOW

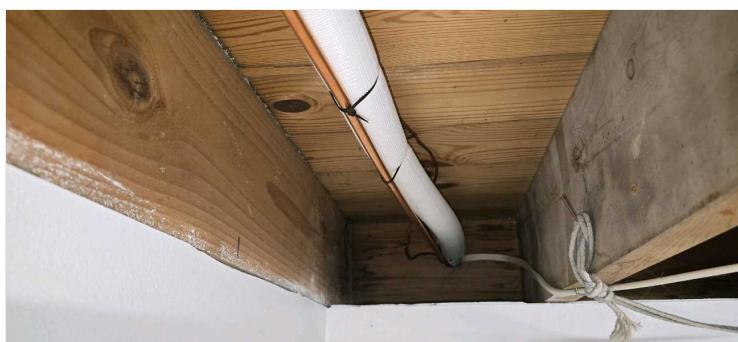
Hvac Line Set

YELLOW

Material: copper tubing with foam insulation Damage: Low

Safety Risk: Low Priority: Routine

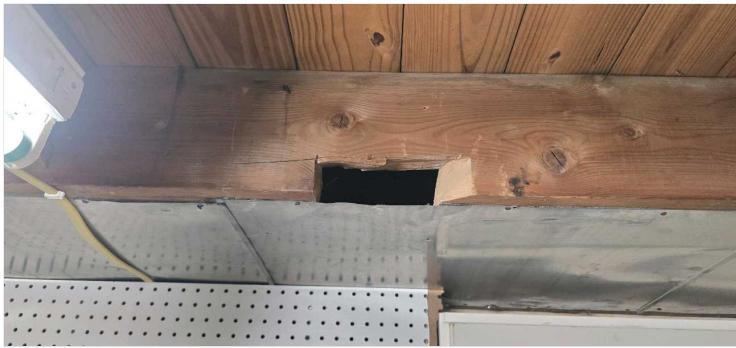
Ceiling Beam/joist

Material: Solid wood Damage: High

Safety Risk: Moderate Priority: Recommended

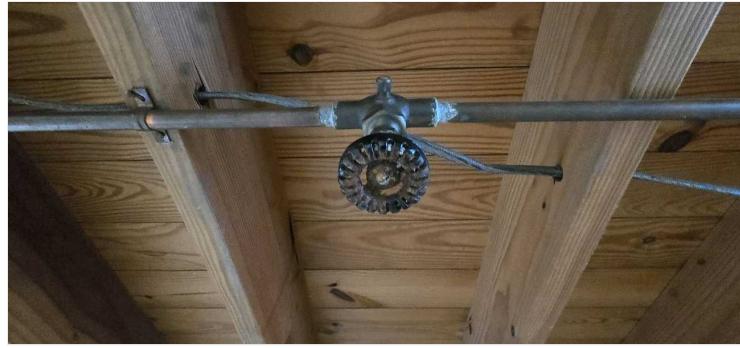
Exposed Sprinkler Head

Material: Metal Damage: Medium

Safety Risk: Moderate Priority: Recommended

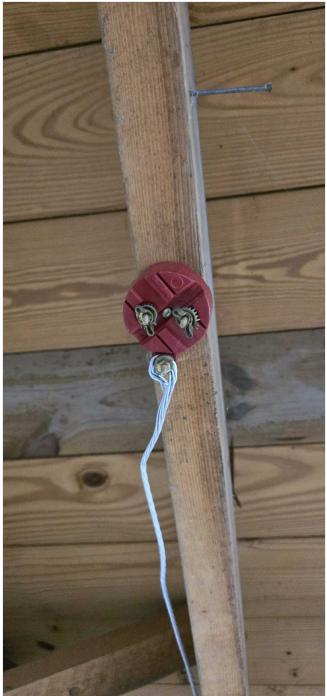
Detector/alarm Mounting Base

Material: Plastic base with metal screw terminals Damage: Medium

Safety Risk: Moderate Priority: Urgent

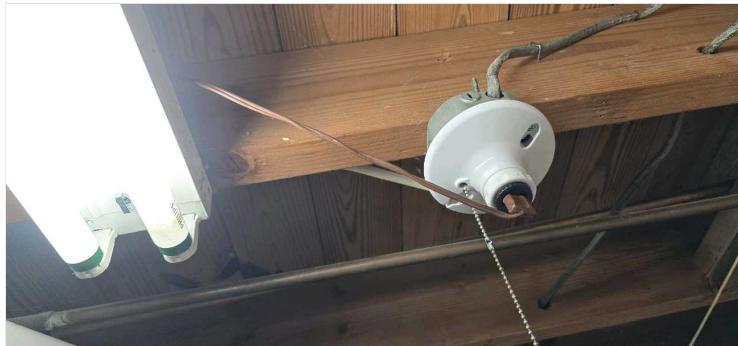
Ceiling Lampholder With Pull-chain RED

Porcelain lampholder mounted to a round metal box; no bulb installed. A bare copper strip/conductor is visibly inserted into the lamp socket opening and draped across the fixture. This creates exposed conductive material at a lighting outlet and is an urgent issue. Fixture appears mechanically secured to the framing; no scorch marks or cracking visible around the base.

Safety Risk: Severe Priority: Urgent

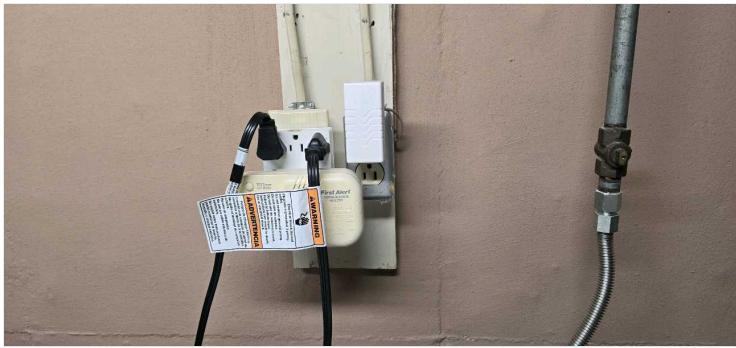
Surface-mounted Duplex Outlet (left) YELLOW

Duplex electrical receptacle mounted on a painted wood backboard with intact cover plate. Partial receptacle face obstructed by plug-in adapters and cords; unverified image incomplete. No exposed conductors or obvious cracks visible on accessible portions.

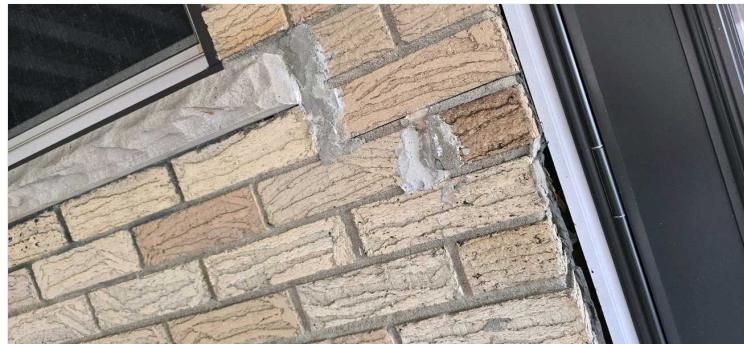
Exterior Brick Veneer At Corner

ORANGE

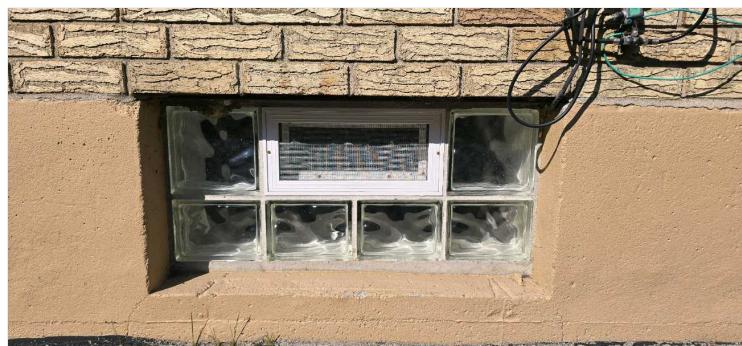
Glass Block Window Assembly With Vent Insert

ORANGE

Safety Risk: Low Priority: Routine
