Date of Report
20 November, 2025

8113 Frontier Ave. Niagara Falls, NY 14304

INSPECTION BRIEF

This AI-generated summary holistically reviews the property's visible condition for pre-listing preparation and buyer disclosure clarity.

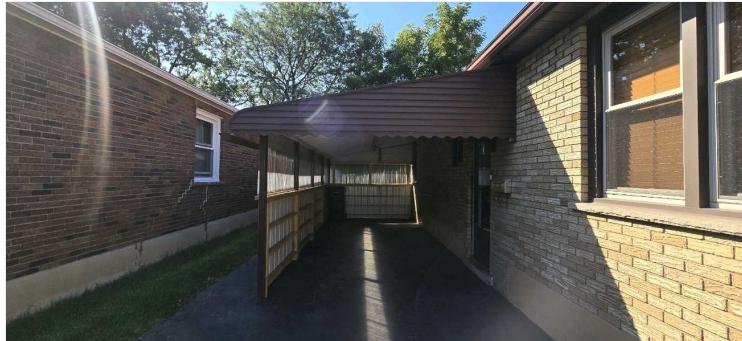
Carport Structure (Condition Notes) YELLOW

Freestanding carport with metal roof, metal supports, and partial side paneling; visually stable with no obvious sagging, breaks, or missing supports; exterior metal and trim appear intact without denting or perforation. Sun fading and minor streaking visible on select panels; all fasteners appear in place. Minor dirt/debris accumulation along lower edges; regular cleaning and touch-up paint on trim would improve showing photos and perceived maintenance. No overt safety hazards evident, but routine check for sharp edges or loose panels advisable prior to showings; routine cosmetic prep item.

Safety/Compliance: No apparent hazard; routine sharp-edge check only.

Material: Metal (roof/panels/supports), possibly vinyl (trim) Damage: Low

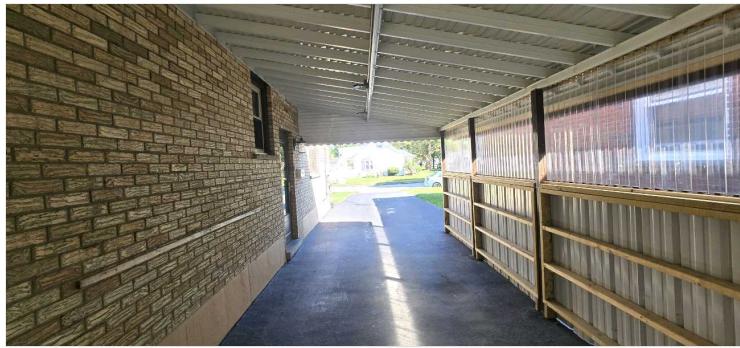
Carport Structure (Presentation Highlights)

Steel and wood-framed carport visible; roof, posts, and wall coverings appear securely fastened and free of warping, corrosion, or significant damage. No visible water stains, sagging, or gaps at joints; translucent wall panels intact, no cracks observed. Surface finish and construction present as stable and recently maintained, supporting strong listing presentation. No life-safety exposures or inspection flag risks apparent. This is a selling point likely to positively impact photography and buyer confidence.

Safety/Compliance: Structure appears properly supported; no evidence of unsafe materials/connections in visible areas.

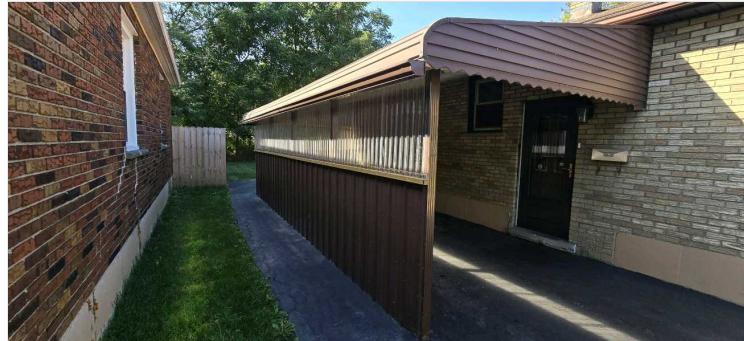
Exterior Carport Structure (Condition Notes)

Metal and polycarbonate carport adjacent to home with visible corrugated sidewalls and integrated overhang; no visible dents, corrosion, or loose panels. Structure appears visually stable and upright with no sagging, bowing, or apparent displacement. Minor debris present on roof edge but no significant buildup. Presentable as a utility feature for protected parking or covered entry. No visible damage or code/integrity issues requiring correction; routine monitoring recommended for ongoing maintenance. Cosmetic cleaning of the polycarbonate panels could enhance appearance for listing photos. Graded as routine cosmetic prep; no safety risks observed.

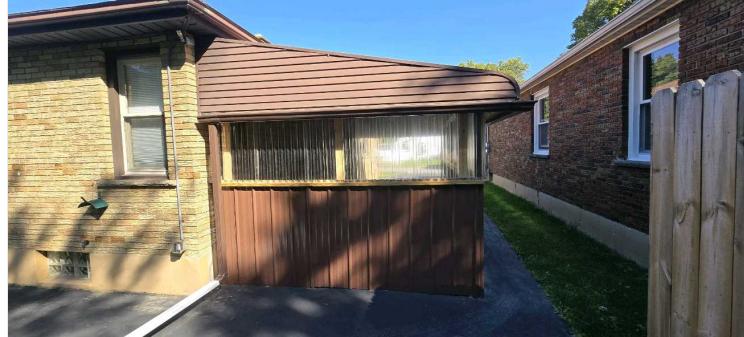
Exterior Addition Structure (Key Disclosures)

Corrugated plastic panels and metal siding; wood framing visible at seams; structure is attached to house exterior and projects into driveway area; panels and framing appear recently installed but inconsistent in alignment and finish; siding color and materials contrast sharply with both adjacent houses, which may draw buyer or appraiser attention to possible non-original, unpermitted, or nonconforming construction. No apparent open gaps, rust, or debris, but the joinery and weatherproofing are not fully visible. Such a visible addition may require disclosure related to build quality, permitting, and insurability. Correcting or improving cohesion with house exterior recommended prior to photography to reduce objections. Priority disclosure due to potential impact on buyer due diligence, lender appraisal, and insurance.

Safety/Compliance: No overt hazards, but suspected non-permitted status increases risk for insurance/lender scrutiny; conforming use verification advised.

Marketability & Asset Impact: Disclosure unavoidable; may lead to price negotiation, additional buyer questions, or repair escrow; if upgraded aesthetically could offset buyer concern.

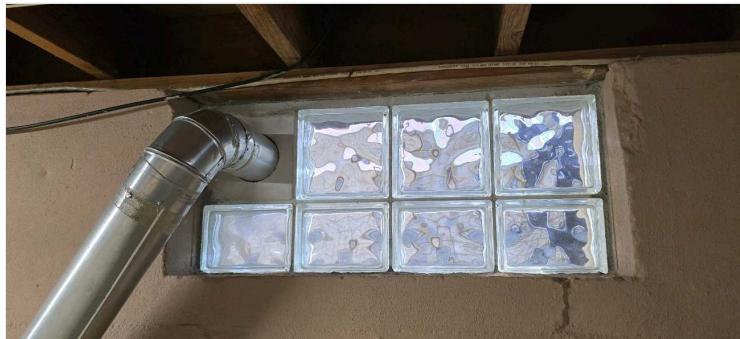
Glass Block Window (Key Disclosures) ORANGE

Safety/Compliance: Metal vent pipe through glass block window leaves unsealed gap risk for air, moisture, pest intrusion, with likely code/appraisal challenge.

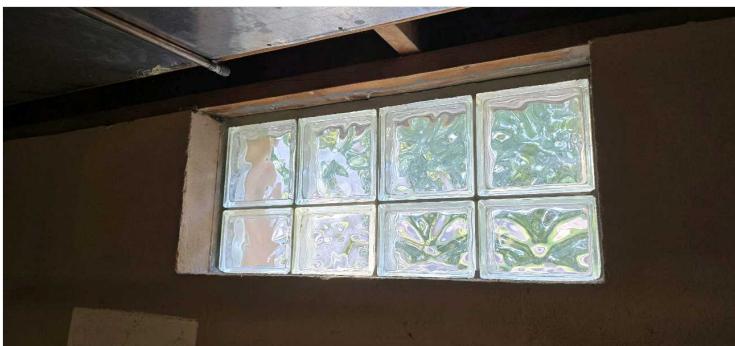
Glass Block Window (Condition Notes) YELLOW

Safety/Compliance: No cracks/gaps in glass or masonry; stable install. Minor mortar/wall irregularities.

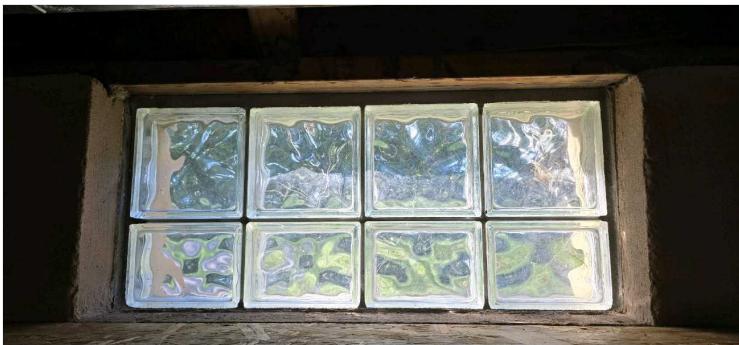
Glass Block Window (Condition Notes) YELLOW

Safety/Compliance: All joints/glass intact, minor cobwebs/dust.

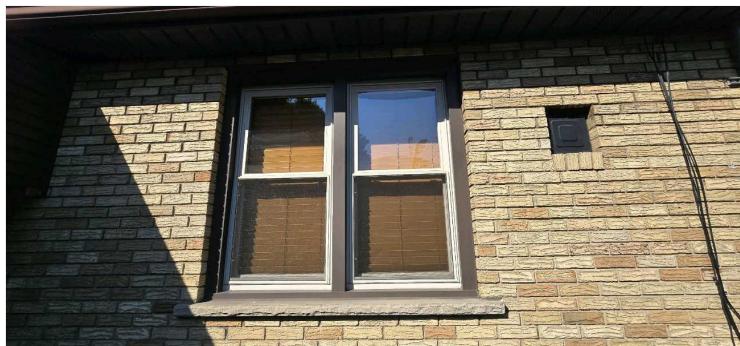
Exterior Window Unit (Condition Notes) GREEN

Double-hung window with vinyl/aluminum frame and glass; intact, minor surface dust. No cracks or warping visible; seals not fully visible unverified image incomplete. Supports appraisal/finance.

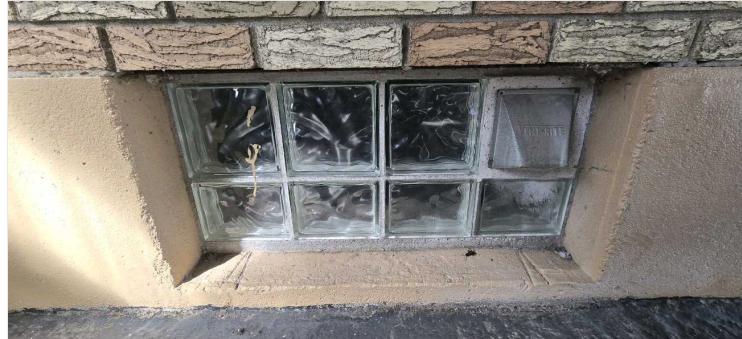
Glass Block Window (Condition Notes) YELLOW

Basement-level glass block panel, metal vent; minor mortar gap at base, visible surface streaks on glass. Intact and stable but needs cleaning and tuckpointing to mitigate buyer concerns.

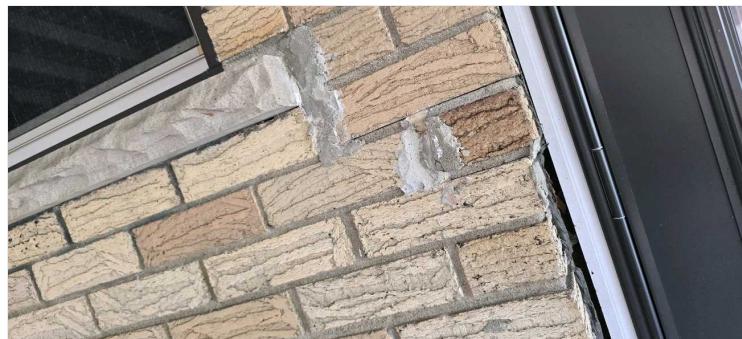
Brick Exterior Wall (Key Disclosures) ORANGE

Brick wall with several patched sections and mortar mismatches by entry; appearance draws attention. No visible loose bricks, but patchwork could raise water or structure questions for buyers/inspector.

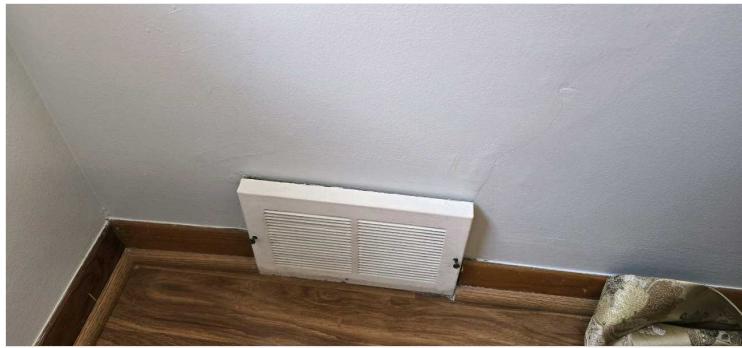
Wall Register Cover (Condition Notes) YELLOW

Painted metal register shows light surface wear, edge chipping, and uneven screw alignment. Stable but could use cleaning or repainting.

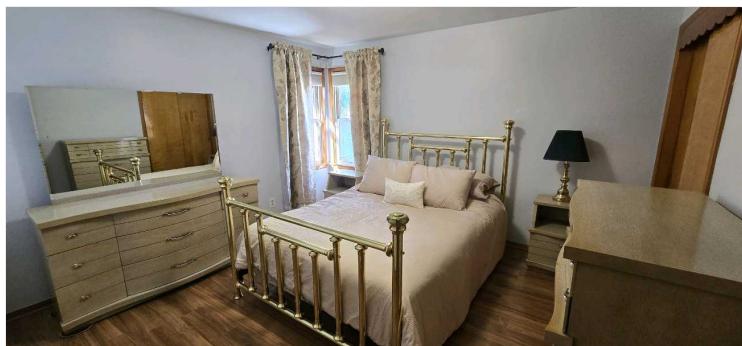
Laminate Flooring (Presentation Highlights) GREEN

Laminate plank floor; no discoloration, chips, or gaps; flush to baseboards and visually uniform.

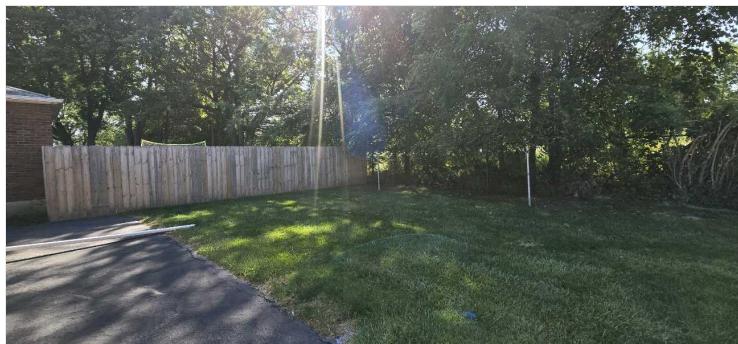
Wood Privacy Fence (Condition Notes) YELLOW

'Safety/Compliance:' No visible failing panels or posts.

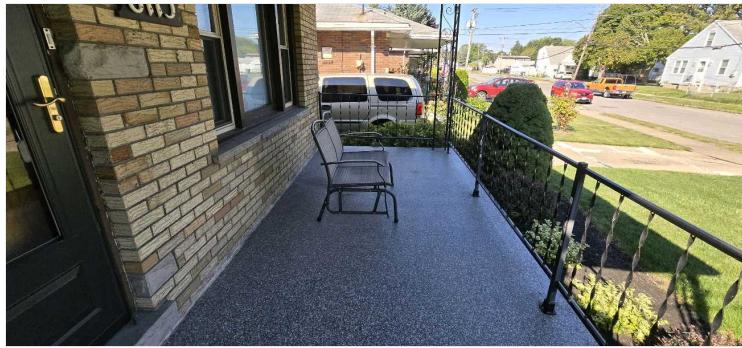
Porch Floor (Presentation Highlights) GREEN

'Safety/Compliance:' Speckled concrete surface in intact condition; no tripping hazard or significant wear.

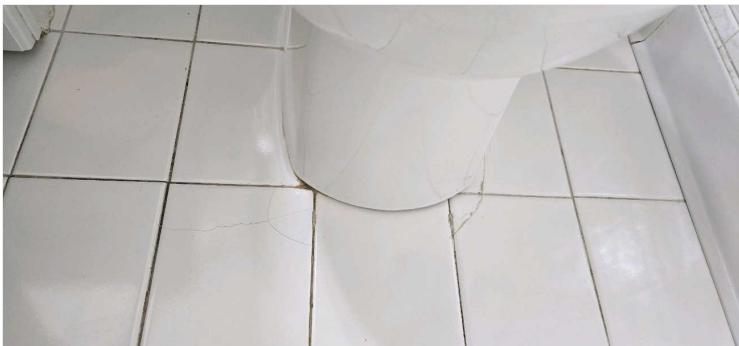
Ceramic Floor Tile (Key Disclosures) ORANGE

White ceramic floor tiles adjacent to the toilet; several visible cracks radiating from grout lines surrounding the toilet base, and one tile shows a pronounced crack extending largely across its surface. Grout at the base of the toilet and in other areas displays visible discoloration and minor separation. The condition represents moderate to high cosmetic wear, with the cracks likely to be prominent in listing photographs and during showings. This may raise buyer concern regarding maintenance history and potential underlying support issues; visible cracks require correction or disclosure prior to listing to avoid negative appraisal or inspection outcomes. Item is a medium-cost flooring repair (CapEx possible) and, if not addressed, should be disclosed per standard listing practice.

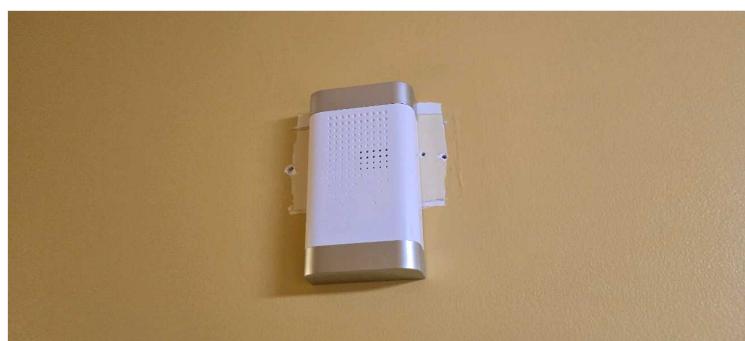
Wall-mounted Device (Key Disclosures) YELLOW

Wall-mounted device surrounded by exposed drywall/unpainted patchwork, with additional small mounting holes; device intact, wall finish incomplete.
