Date of Report: 24 February, 2026 9:32pm EST

PropertyManager - MidTenancy

2965 Jerauld Ave

Betsy House

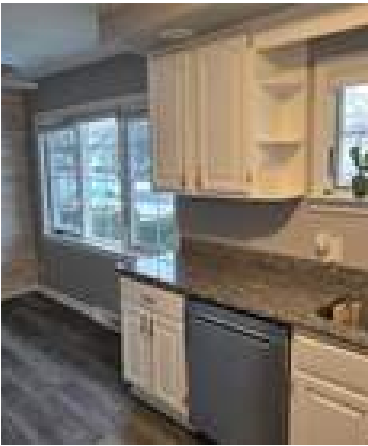
## Kitchen sink and faucet

Excellent

Stainless steel double-basin sink and faucet are clean, with intact caulk and no visible leaks or corrosion. Countertop junctions are tight with no water intrusion noted.

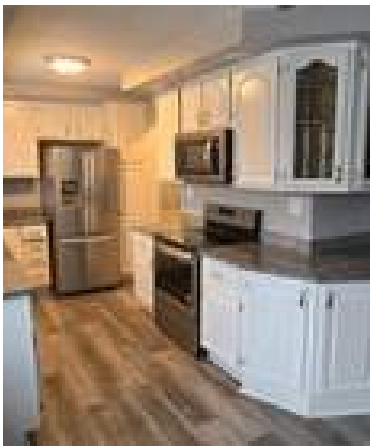
## Laminate Flooring

Excellent

Laminate flooring has no visible scratches, stains, or warping. Edges and seams are secure, and there are no trip hazards.

**Next Action:** Continue standard cleaning and check for loose seams.

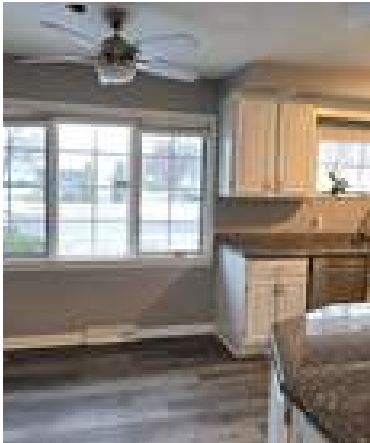
## Window assembly (main dining/kitchen area)

Excellent

Three-panel glass window and trim are intact without visible chips, cracks, or warping. Latch and lock are not clearly shown.

- Safety/Compliance: No hazard detected from this distance.
- Asset Impact: High-quality appearance maintained; check hardware on next inspection.

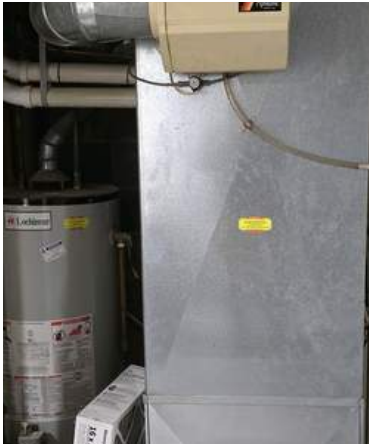
### HVAC unit (furnace/air handler)

Excellent

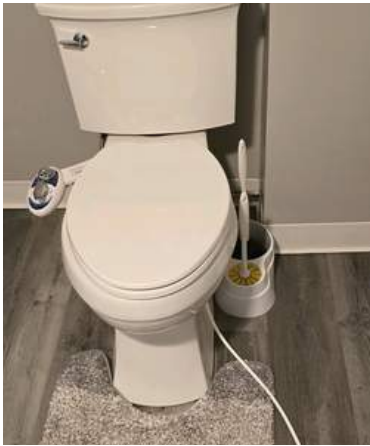
## Toilet (porcelain, tank and bowl)

Excellent

**Next Action:** Monitor according to standard schedule; no immediate action.

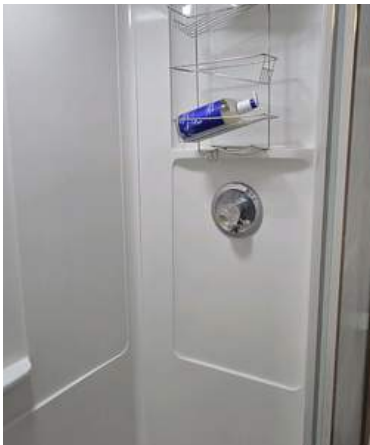
## Shower enclosure

Excellent
