Date of Report
13 October, 2025

PROPERTY INFORMATION

8113 Frontier Ave. Niagara Falls, NY 14304

INSPECTION BRIEF

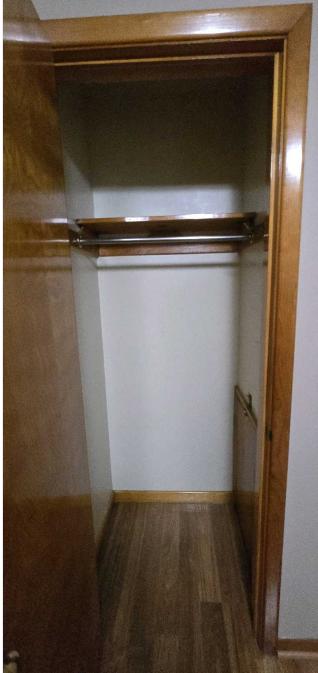
Closet Door And Frame

Partial varnished wood door and matching frame visible; surfaces appear clean with no visible cracks, holes, or warping; hinge side and latch hardware are not fully shown; unverified image incomplete

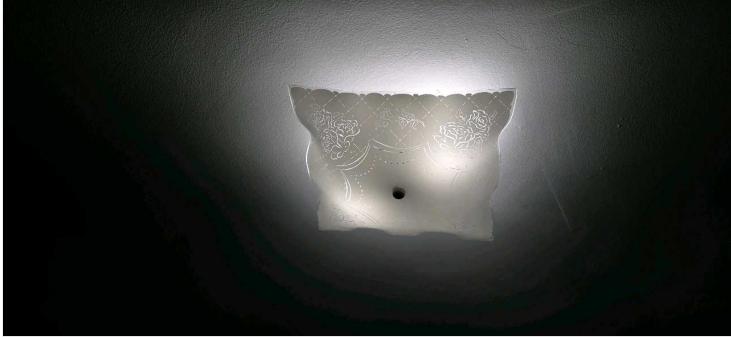
Ceiling Surface

Partial only the area surrounding the fixture is visible; textured painted ceiling shows no visible cracks, holes, or stains; the bright halo and darker perimeter are lighting effects from the fixture, not damage unverified image incomplete

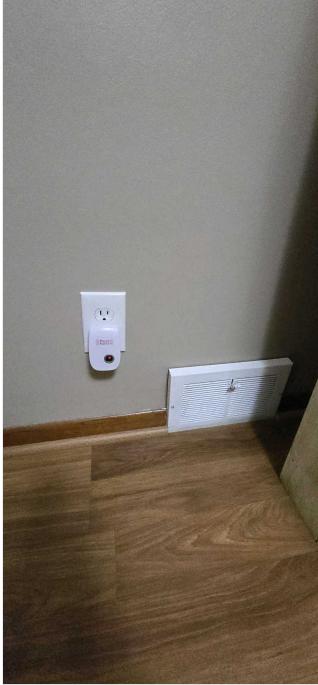
Electrical Outlet

Partial Duplex electrical outlet with cover plate; lower portion is blocked by a plug-in device, so full condition cannot be seen unverified image incomplete. Visible areas show intact plastic cover with no cracks, no discoloration, and no exposed wiring.

Next Action: Verify condition when accessible.

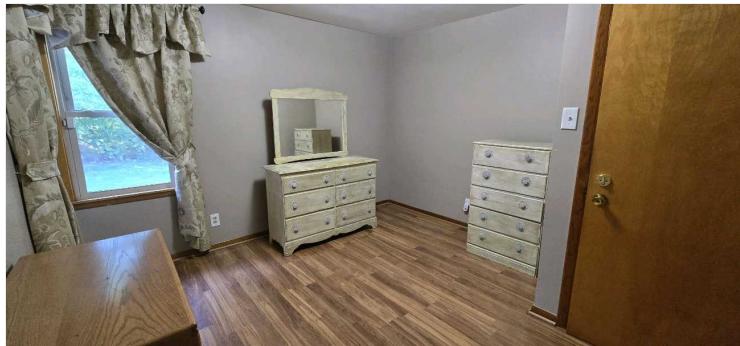
Laminate Floor

Laminate plank flooring with consistent finish; no visible gaps, buckling, or surface damage in the areas shown.

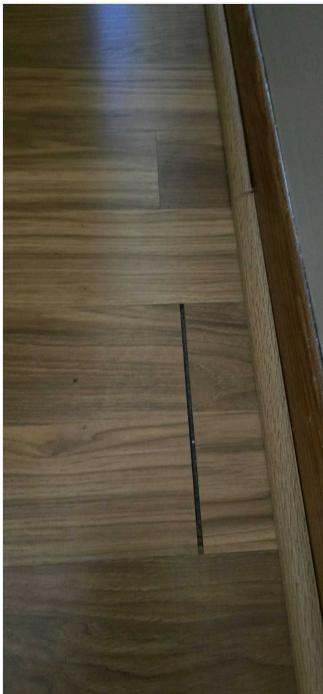
Flooring Plank Seam Separation

Wood-look laminate/vinyl plank floor shows an open longitudinal seam between two planks, width visibly several millimeters, extending vertically through the frame. Edges appear flat with no observable height difference. Minor surface specks present. The bright band on the left is light glare, not staining. This is a priority condition note due to potential catch point for footwear and debris intrusion.

Asset Impact: Repair avoids further plank separation or edge damage.

Material: Laminate/vinyl plank Damage: Medium

Safety Risk: Moderate Priority: Recommended

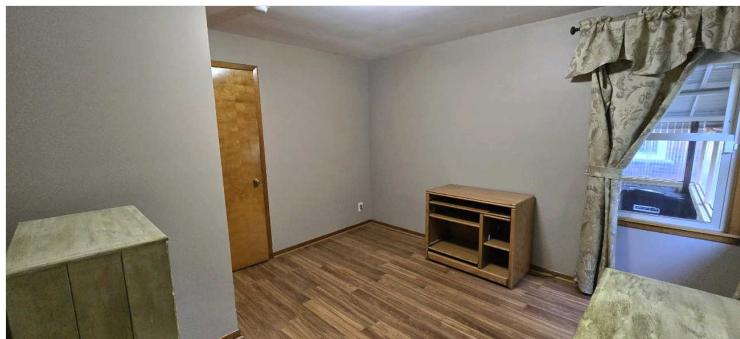
Laminate Plank Flooring

Wood-look laminate plank flooring appears even with tight seams and no visible lifting, gaps, chips, or distinct stains; tonal variations appear consistent with the materials pattern and not damage; in excellent condition for turnover.

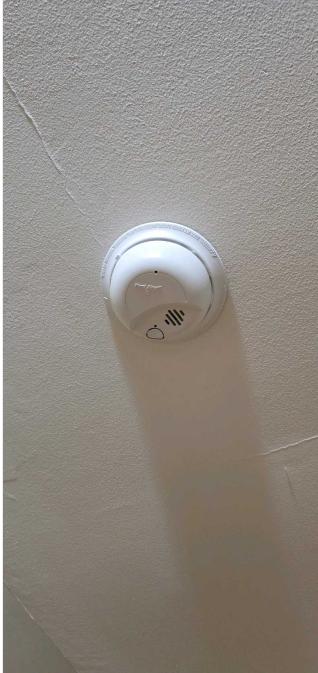
Ceiling-mounted Smoke Detector

Round plastic smoke detector appears securely mounted to the ceiling with housing and cover intact; no visible cracks, gaps, missing parts, or exposed wiring. Overall presents in excellent condition.

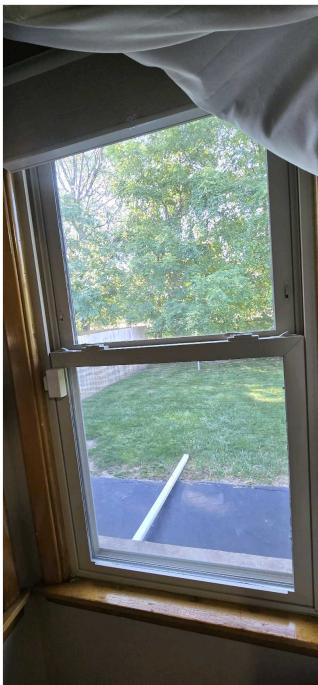
Window Frame And Sashes

Partial portions of the upper frame, exterior side, and weatherstripping are not visible; vinyl-framed double-hung style window with two visible glass panes that appear intact with no cracks or chips; frame and tracks show no visible breaks or warping; unverified image incomplete

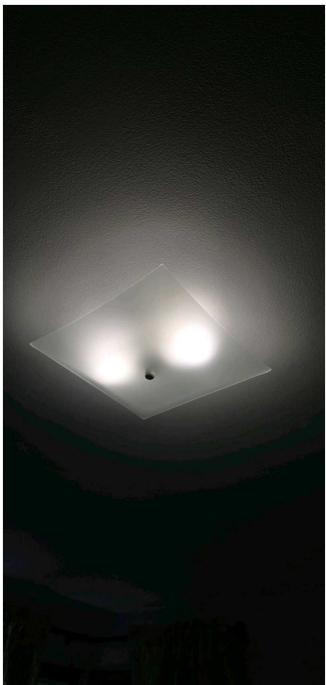
Ceiling Light Fixture

Square flush-mount ceiling light with frosted glass shade and a central fastener; cover appears intact with no visible cracks or chips; two bright points are visible through the shade indicating bulbs behind the diffuser; no exposed wiring or missing cover observed; current presentation appears in excellent condition.

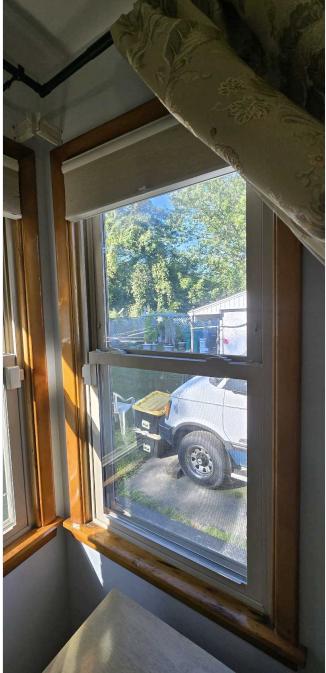
Window Assembly (double-hung)

Vinyl-framed double-hung window with clear glass panes appears intact; no visible cracks, chips, or warping; frame and tracks appear clean; overall in excellent condition.

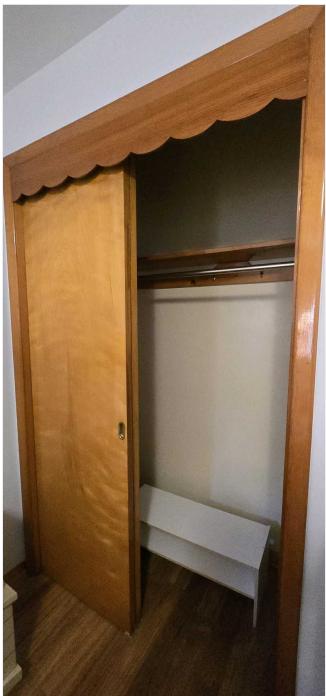
Sliding Closet Door Assembly

Partial wood sliding closet door with one panel open; visible panel surface appears smooth with no chips or cracks and sits plumb within the jamb; the opposite panel and the upper/bottom tracks are concealed by the header trim and door position; unverified image incomplete.

Asset Impact: No visible issue but full check recommended.

Next Action: Recommended verify operation and rollers.

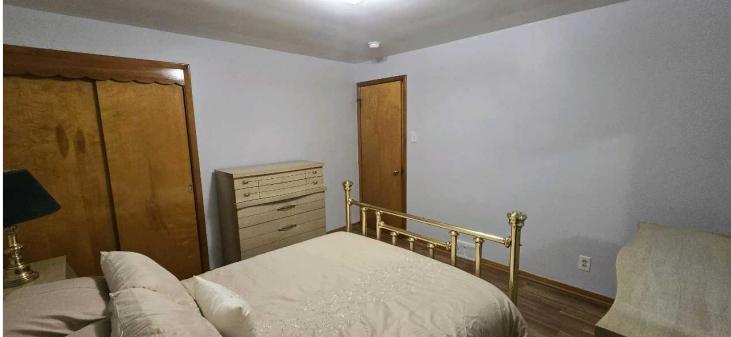
Walls

Partial painted drywall walls with smooth, even finish and no visible cracks, holes, or stains; areas are obstructed by furniture and extend out of frame; excellent condition overall; unverified image incomplete.

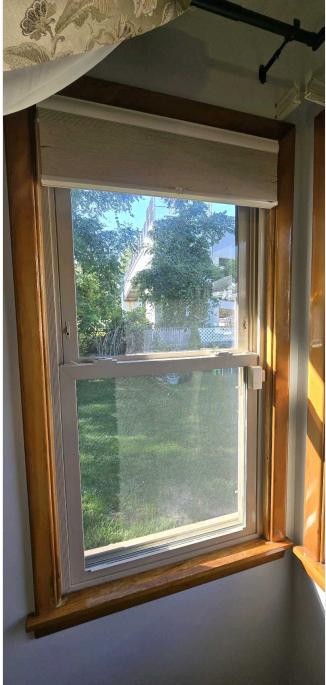
Double-hung Window Assembly

Interior view of a vinyl-framed double-hung window; glass panes appear intact with no visible cracks or chips; frame and tracks appear clean with typical reflections from lighting. Latch hardware not clearly visible from this angle.

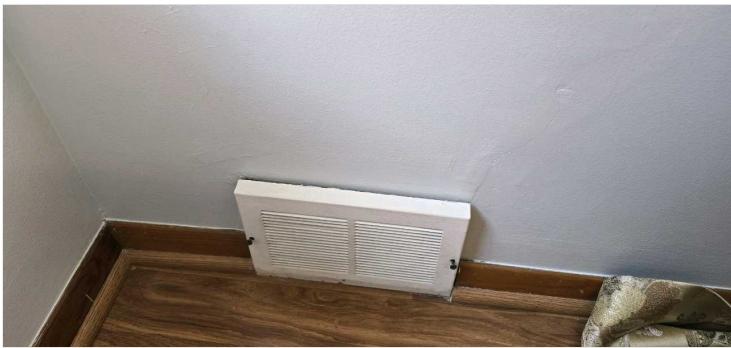
Wall Hvac Register Cover

Wall-mounted louvered register cover near floor; painted metal surface shows minor paint wear at lower edge and slight misalignment with visible gaps at the right and bottom edges between the cover and wall. Screws are present and appear seated. This is a routine maintenance item.

Safety/Compliance: No urgent risk, but reseating recommended to avoid debris entry.

Asset Impact: Minor paint wear and gap may require sealing.

Next Action: Routine adjustment; monitor for loosening.

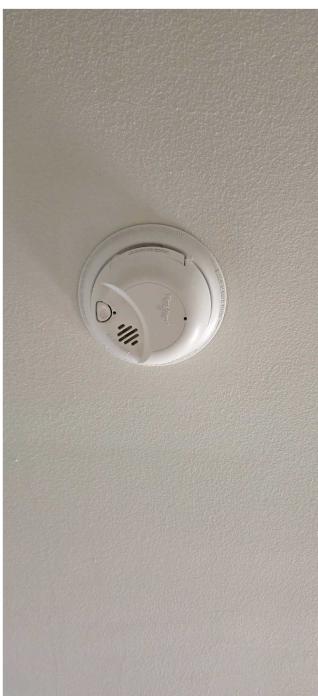
Ceiling-mounted Smoke Detector

Ceiling-mounted smoke alarm with intact plastic housing and mounting ring; unit sits flush to the ceiling with test/silence button and sound grille visible. No cracks, discoloration, dust buildup, or exposed wiring observed; presents in excellent condition.

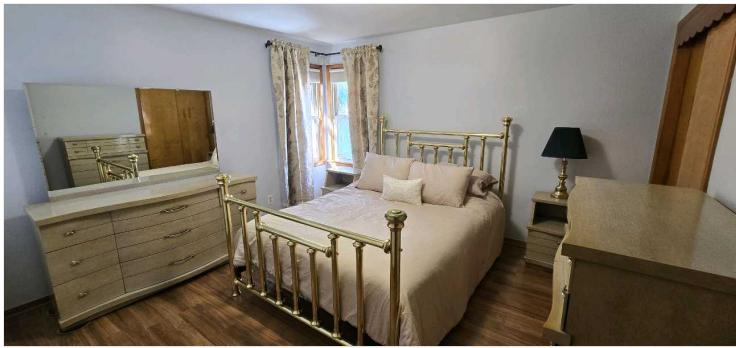
Window Assembly

Partial bay-style wood-framed window; portions of frame and sashes are obscured by curtains and adjacent furniture; visible glass is clear and trim appears intact with no visible cracks, chips, or water staining; appears in excellent condition. unverified image incomplete.

Safety/Compliance: No visible hazards but cannot confirm full egress compliance.

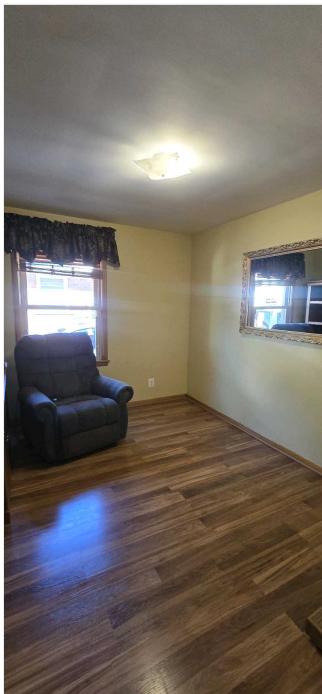
Laminate Flooring

Wood-look laminate plank flooring with an even finish; no visible gaps, lifting, chips, or moisture swelling. Light reflections are from illumination, not damage. Surface in excellent condition.

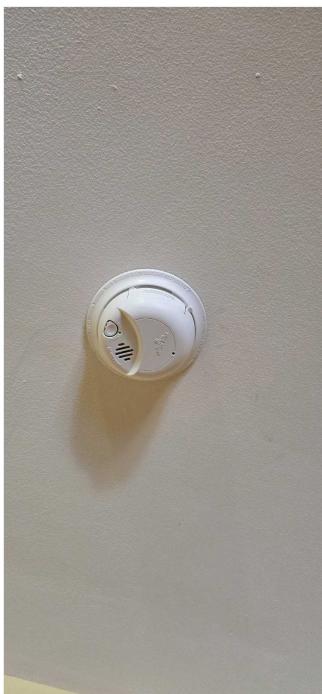
Smoke Detector (ceiling-mounted)

Round smoke detector mounted on the ceiling; plastic housing and mounting ring appear flush to the surface with no visible gaps, cracks, or missing parts; vents and exterior surface show no notable dirt or discoloration; overall in excellent condition.

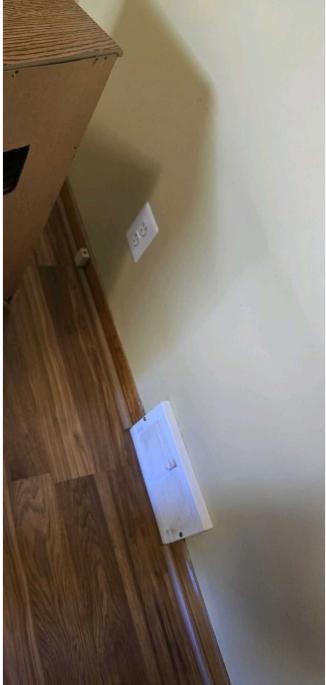
Electrical Outlet

Standard duplex outlet with intact plastic cover plate; no visible cracks, missing screws, or discoloration. Surrounding wall shows no scorch marks. Appears in excellent condition.

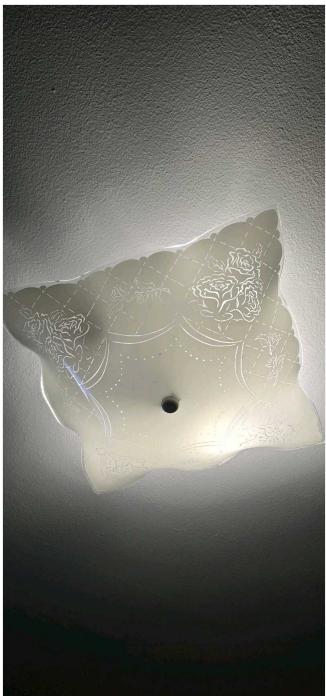
Ceiling Surface

Partial only a portion of the painted textured ceiling surface is visible; appearance is uniform with no distinct cracks, holes, or water stains observed; tonal variation appears to be illumination rather than damage unverified image incomplete.

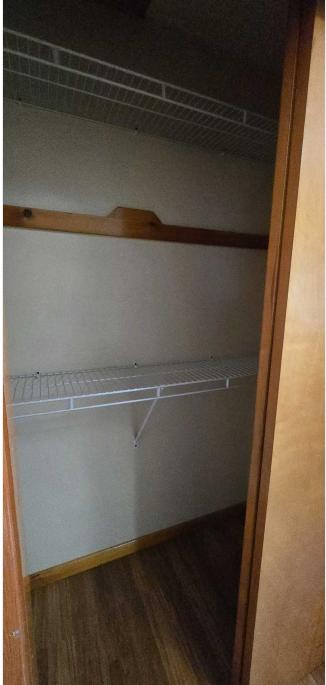
Lower Wire Shelf

White coated metal wire shelf mounted along the back wall with wall clips and a diagonal support bracket; appears level with no visible bending, rust, or loose fasteners. Considered in excellent condition for use.

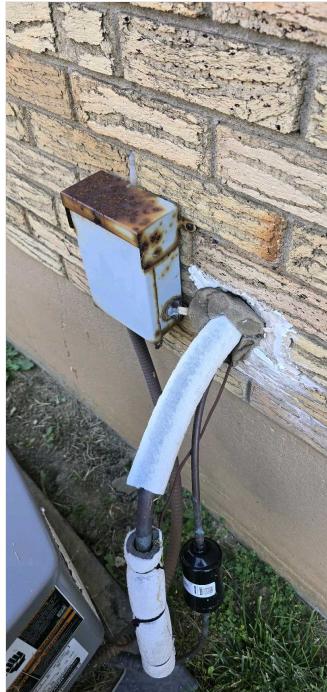
Refrigerant Suction Line Insulation

Material: Foam insulation on copper refrigerant line Damage: Medium

Safety Risk: Low Priority: Recommended

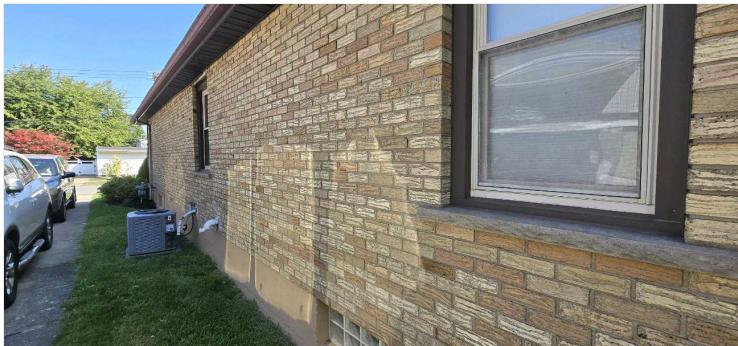
Brick Exterior Wall And Mortar Joints GREEN

Brick masonry veneer along the side elevation with uniform mortar joints; no loose bricks, spalling, or visible cracking. Bright areas on the wall appear to be light reflections, not staining. Overall in excellent condition.

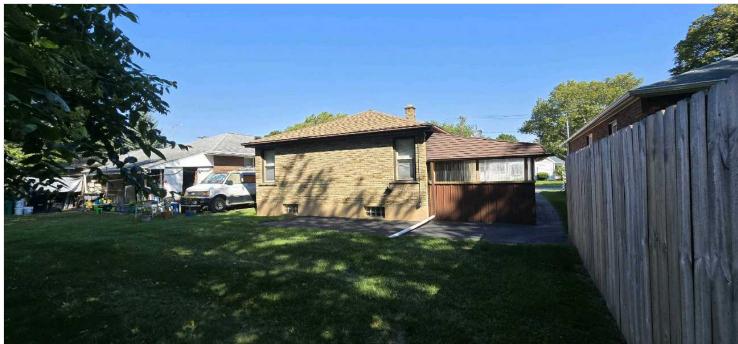
Exterior Brick Wall And Mortar GREEN

Brick masonry exterior wall with intact, even mortar joints; no visible cracks, spalling, or efflorescence. Tree shadows are present on the wall and are not staining. Wall-mounted fixtures appear secure with no visible damage.

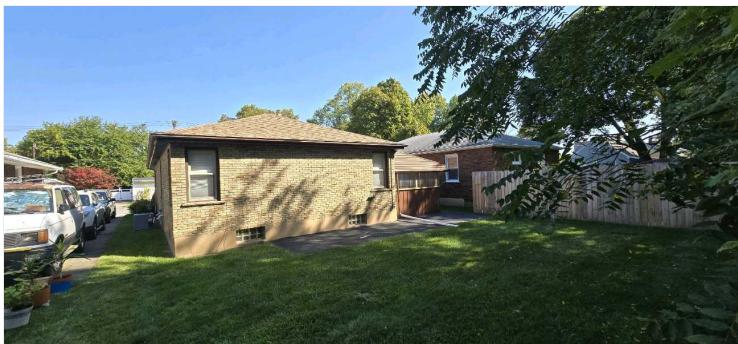
Exterior Brick Wall GREEN

Clay brick masonry siding with uniform mortar joints; no visible cracks, spalling, bulging, or efflorescence. Tree shadows present; no confirmed staining. Overall in excellent condition.

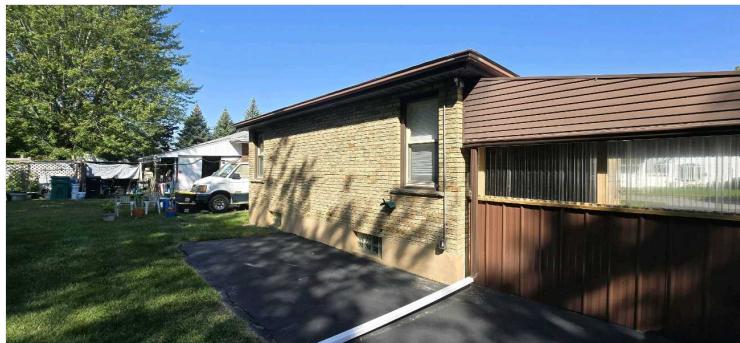
Exterior Brick Veneer Wall And Foundation

GREEN

Brick veneer siding and parged foundation along side elevation appear uniform with no visible cracks, spalling, or missing mortar in the areas shown. Tree shadows are present on the wall and should not be mistaken for staining. Overall in excellent condition.

Material: Brick veneer over parged concrete Damage: Low

Safety Risk: None Priority: Routine

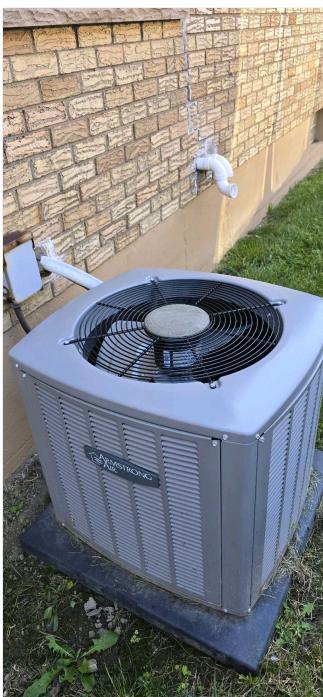
Outdoor Hvac Condenser Unit

GREEN

Partial rear and service panel unverified image incomplete. Powder-coated metal housing and top steel fan guard show no visible dents; coil fins appear straight on visible sides. Overall presents in excellent condition.

Material: Powder-coated metal with steel fan guard Damage: Low

Safety Risk: None Priority: Routine

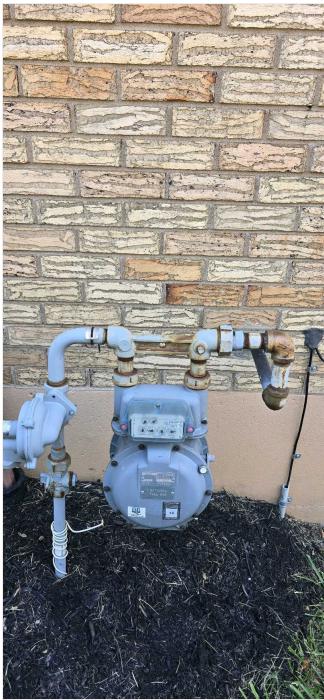
Gas Meter Housing And Mounting

GREEN

Exterior gas meter housing mounted to the wall with a metal bracket; painted metal casing and clear dial cover appear intact with no dents or missing fasteners visible. Present condition reads as in excellent condition.

Asset Impact: Mount and case prevent tampering/damage.

Material: Painted metal Damage: Low

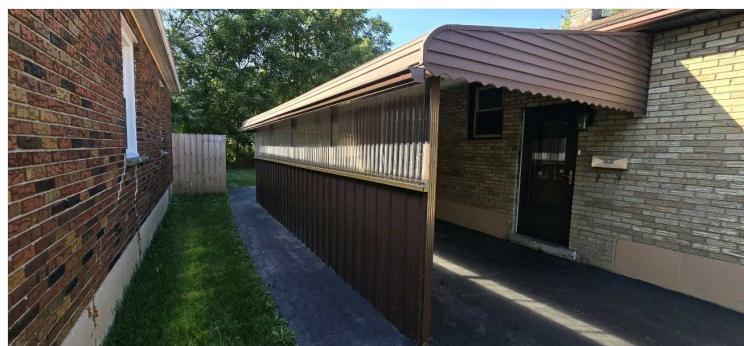
Carport Canopy And Support Posts

GREEN

Partial metal canopy over the side entry with metal support posts appears straight in visible section with minor surface wear. No holes or detachments observed. Remainder extends beyond frame unverified image incomplete.

Safety/Compliance: No functional instability observed.

Material: Formed metal roofing and posts Damage: Low

Metal entry door and surrounding frame appear intact and aligned. Concrete/stone threshold has a chipped front edge and visible spalling at the corner, which could catch footwear at the step. Repair is recommended before occupancy to reduce trip hazard.

Material: Metal door; concrete/stone threshold Damage: Medium

Safety Risk: Moderate Priority: Recommended

Next Action: Complete repair of threshold.

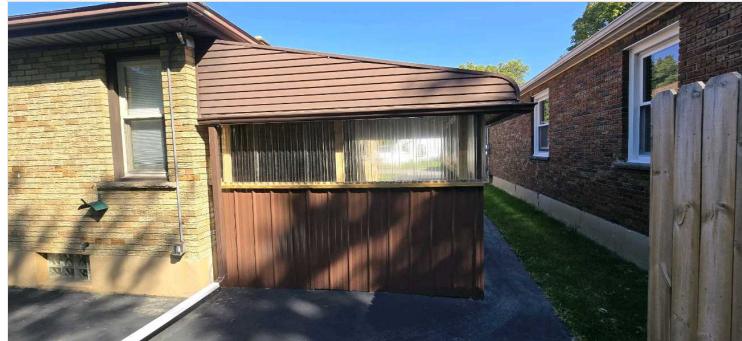
Attached Exterior Enclosure (front elevation)

YELLOW

Safety/Compliance: No immediate risks observed.

Asset Impact: Routine cleaning and possible finishing of exposed wood recommended to maintain longevity.

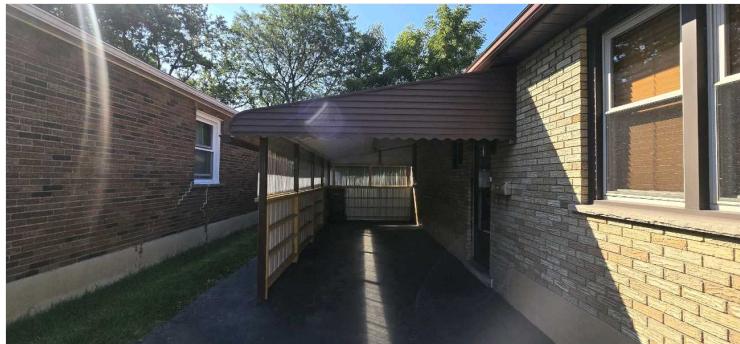
Carport Canopy

GREEN

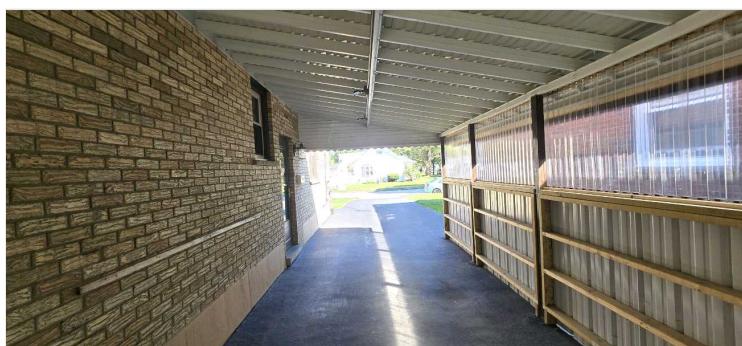
Carport Ceiling/roof

GREEN

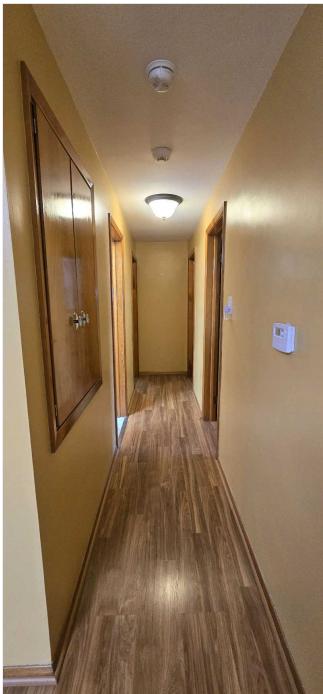
Ceiling-mounted Detector (near foreground)

GREEN

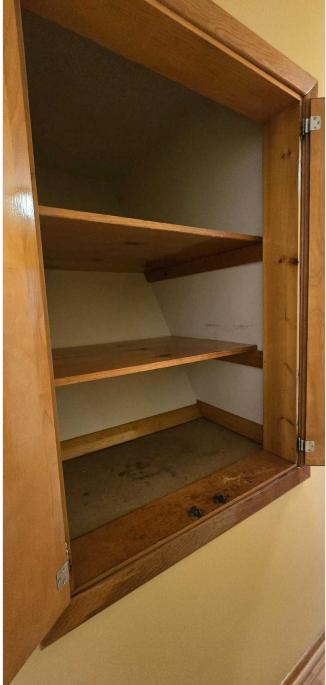
Built-in Wooden Shelves And Base

YELLOW

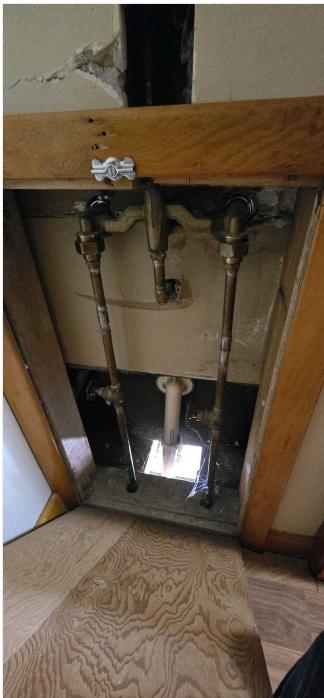
Sink/vanity Fixture

ORANGE

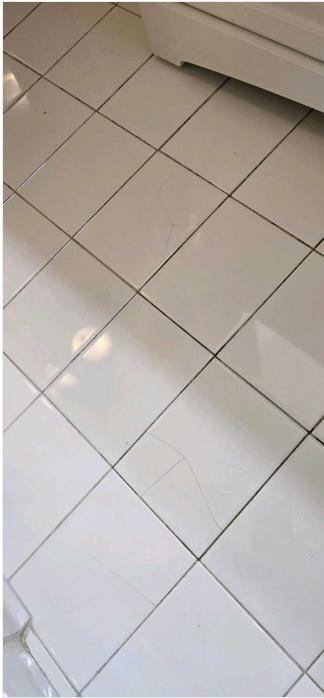
Ceramic Floor Tiles

ORANGE

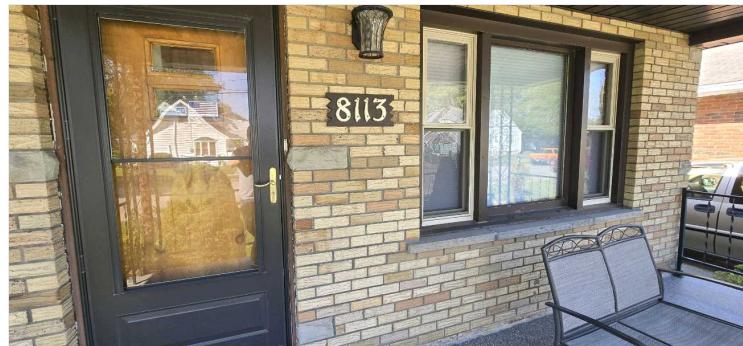
**Exterior Storm Door****GREEN**

Metal-framed storm door with full glass insert and lever handle; glazing intact and frame appears square with no visible dents or warping. Entry clearance is unobstructed.

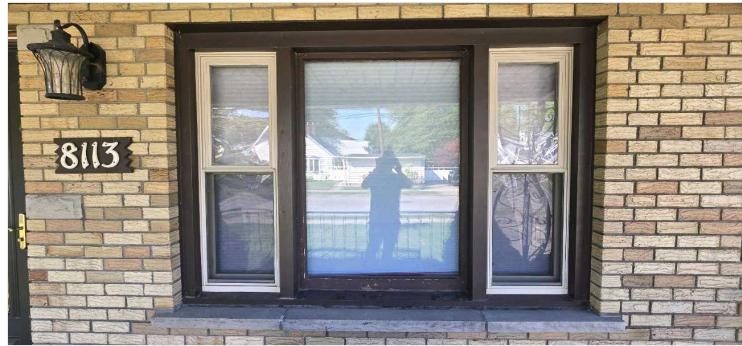
Center Fixed Window Glazing And Frame

YELLOW

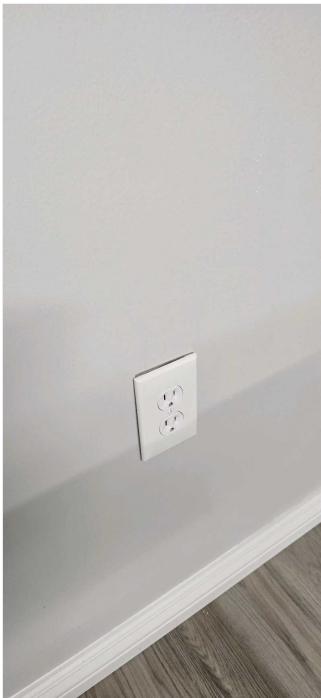
Duplex Outlet And Cover Plate

YELLOW

Material: Thermoplastic cover and receptacle Damage: Low

Safety Risk: Low Priority: Routine

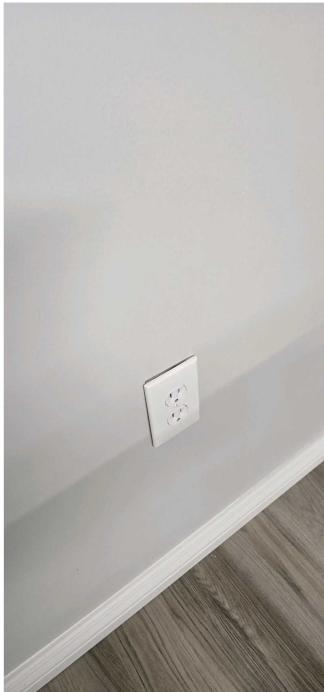
Duplex Electrical Outlet And Cover Plate

ORANGE

Material: Plastic cover plate with recessed electrical receptacle Damage: Medium

Safety Risk: Moderate Priority: Recommended

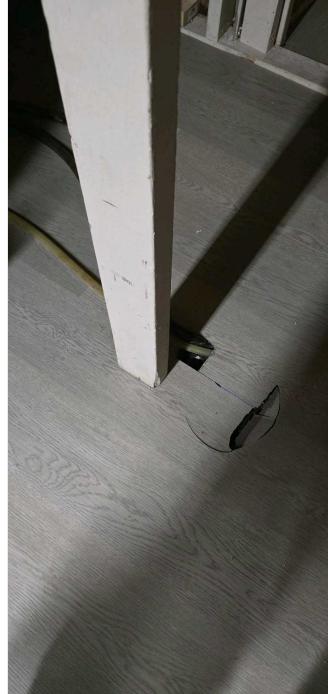
Flooring Wood-look Plank

YELLOW

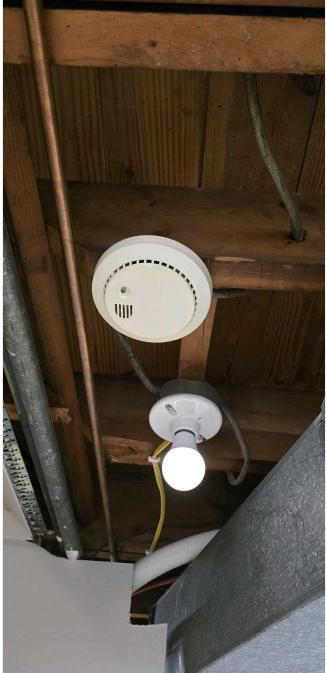
Ceiling-mounted Detector/alarm (type not labeled)

Round plastic alarm mounted to the underside of a wood joist; housing appears intact with surface yellowing; no cracks or missing cover visible. Partial manufacturing date and power source unverified image incomplete.

Safety/Compliance: No visible hazards present, but verification of installation details recommended.

Material: Plastic housing on wood joist Damage: Low

Safety Risk: None Priority: Routine

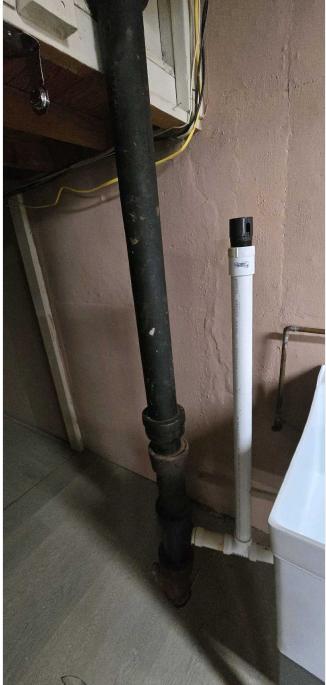
Cast Iron Waste Stack

Vertical cast iron drain/vent pipe with multiple areas of surface corrosion and worn finish at joints; no active moisture visible on exposed sections.

Safety/Compliance: Routine maintenance disclosure; no immediate leak risk visible.

Asset Impact: Surface corrosion should be tracked and touched up during next maintenance cycle.

Material: Cast iron Damage: Medium

Next Action: Clean and seal or repaint corroded sections in line with standard care schedule.

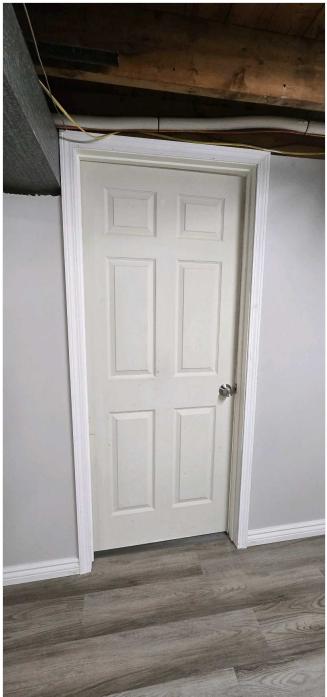
Interior Door Slab

Sixpanel painted door with minor surface scuffs and a visible undercut gap at the bottom relative to the flooring; no holes or cracks observed.

Asset Impact: Only routine wear; touch-up during turnover.

Material: Painted wood/composite Damage: Low

Safety Risk: None Priority: Routine

Next Action: Schedule for next turnover paint/repair cycle.

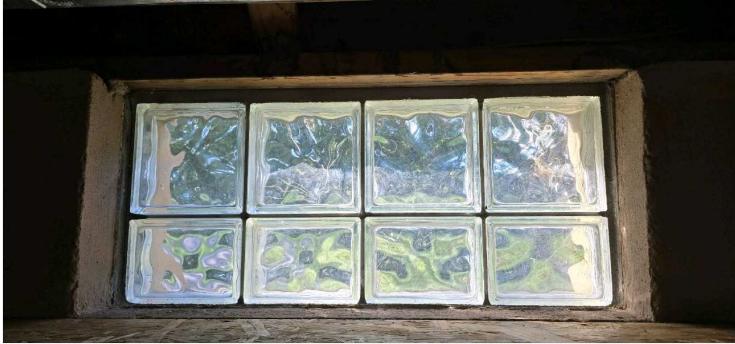
Glass Block Window Assembly

Eight glass blocks in two rows within a masonry opening; all blocks intact with no visible cracks or chips; distortion patterns are inherent to the glass; reveals appear even.

Safety/Compliance: No visible hazards.

Material: Glass block with mortar grid Damage: Low

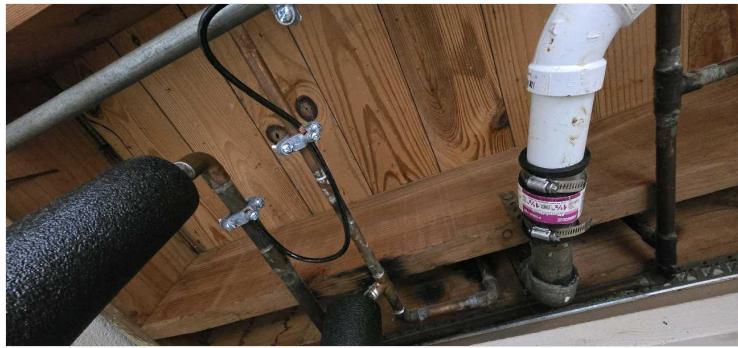
Drain Assembly With Rubber Coupling GREEN

Partial PVC drain elbow connected to a metal drain pipe using a flexible rubber coupling with two stainless band clamps; surfaces show light grime with no visible cracks or moisture; joint appears seated and secure; excellent condition for turnover unverified image incomplete.

Safety/Compliance: No active leak or instability visible.

Material: PVC, rubber coupling, stainless steel clamps, metal drain pipe

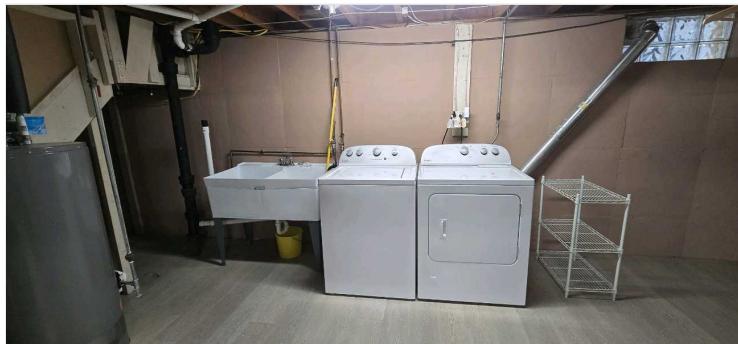
Laundry Utility Sink And Faucet GREEN

Molded plastic utility sink on legs with metal faucet; basin and exterior surfaces appear intact with no visible cracks or chips; surrounding floor shows no standing water.

Safety/Compliance: No indication of leaks.

Material: Plastic/composite sink with metal faucet Damage: Low

Safety Risk: None Priority: Routine

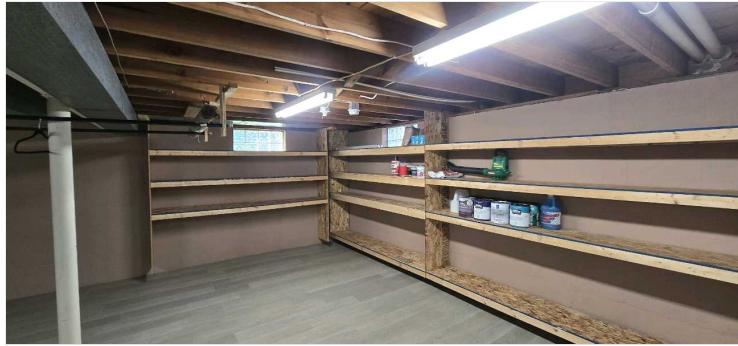
Built-in Wall Shelving

Multi-bay built-in wood shelving along two walls; OSB shelf decks with dimensional lumber framing show minor surface wear and dust with no visible sagging, cracks, or broken supports; in serviceable condition for storage.

Material: Engineered wood (OSB) and dimensional lumber Damage: Low

Safety Risk: None Priority: Routine

Asset Impact: Routine dusting/inspection recommended.

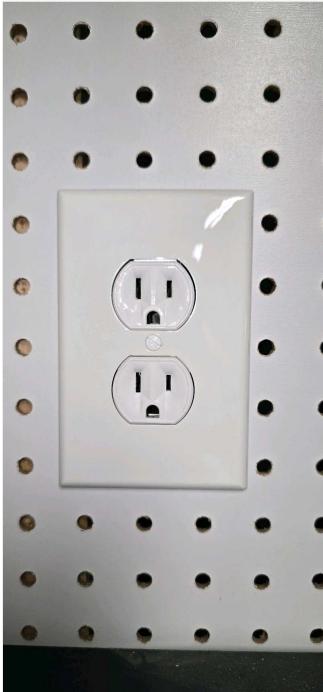
Duplex Electrical Outlet With Cover Plate

Tworeceptacle outlet with matching plastic cover appears intact and seated flush to the wall; mounting screw present; no visible cracks, chips, gaps, or discoloration; no exposed wiring or scorch marks. Overall in excellent condition.

Safety/Compliance: No deficiency.

Asset Impact: No repairs necessary.

Material: Plastic cover and receptacle Damage: Low

Safety Risk: None Priority: Routine

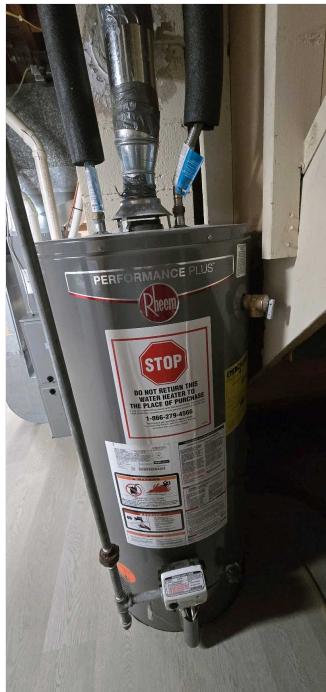
Gas Water Heater Tank And Exterior

Partial rear and left side not visible; unverified image incomplete. Enamel-coated steel tank exterior appears intact with readable safety/operation labels and no visible rust, dents, or moisture on the viewable sides.

Material: Enamel-coated steel Damage: Low

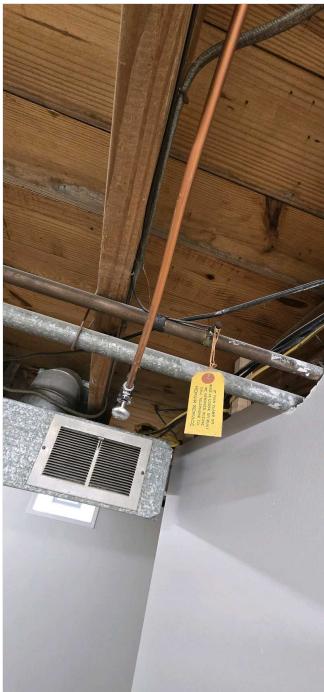
Hvac Duct And Grille

Exposed galvanized metal duct with rectangular steel grille appears intact with minor surface wear; grille is secured with screws and no visible deformation or obstruction; in excellent condition based on the visible section.

Material: Galvanized steel duct and steel grille Damage: Low

Safety Risk: None Priority: Routine

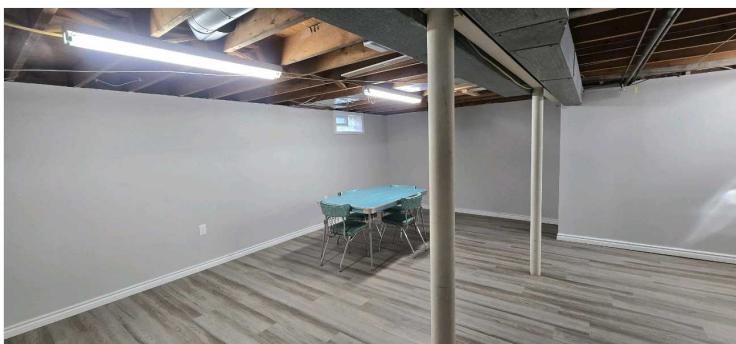
Exposed Ceiling Framing

Unfinished exposed wood joists and beams with visible fasteners; surfaces appear intact with no distinct cracks, sagging, or water staining visible under current lighting. This is in excellent condition for an unfinished ceiling.

Material: Wood framing Damage: Low

Safety Risk: None Priority: Routine

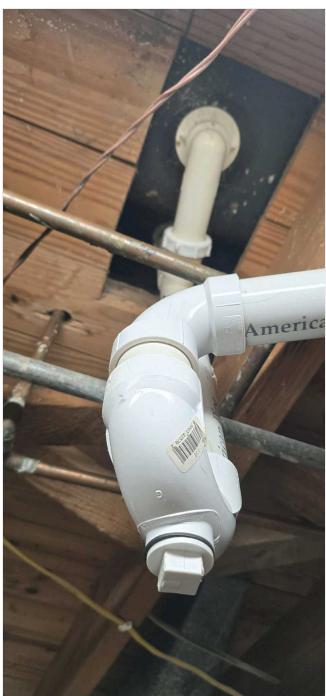
Pvc Drain/cleanout Assembly

PVC drain piping with multiple fittings and a cleanout plug; surfaces show light scuffs and manufacturer labels; no visible cracks, gaps, or moisture at the joints. Overall appears in excellent condition.

Material: PVC Damage: Low

Safety Risk: None Priority: Routine

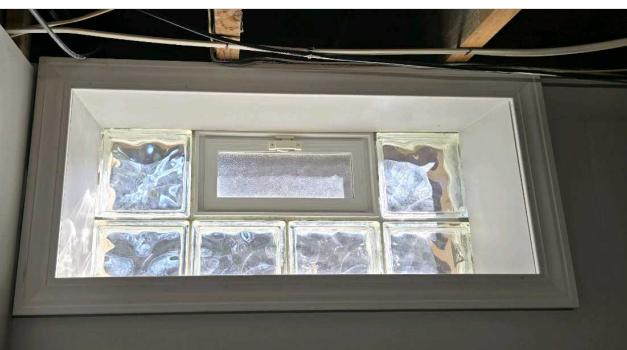
Glass Block Window Assembly

Textured glass block array with central vent opening appears intact; all visible blocks show no cracks, chips, or missing mortar. Light reflections are present on the glass and should not be interpreted as damage. Overall in excellent condition.

Material: Glass block with mortar joints Damage: Low

Safety Risk: None Priority: Routine

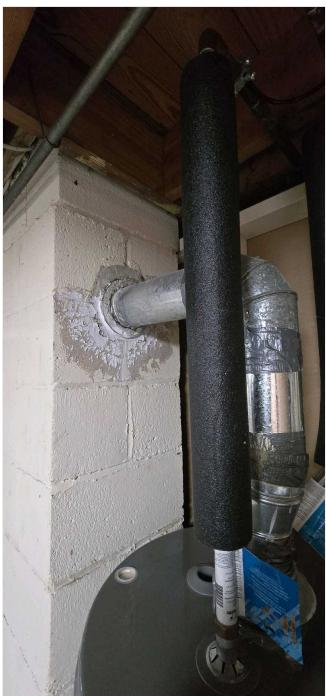
Water Heater Vent Connector

Galvanized metal vent connector runs from the appliance to a masonry wall thimble; seams are wrapped with reflective tape and appear continuous with no visible gaps or deformation from this angle. Surface shows minor scuffs only; condition appears in excellent condition.

Safety/Compliance: No gas or vent leak evident.
