Date of Report: 24 February, 2026 9:33pm EST

1314 Norwood Avenue Chelsey

Inspection Brief

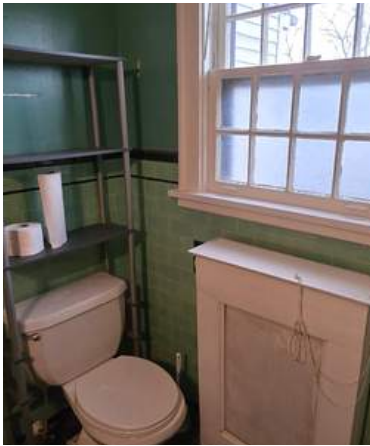
Window (Key Disclosures)

Fair

Original wood window is stable. Fogged or misaligned blinds and a loose blind cord diminish safety perception and should be addressed. Older window type may prompt buyer questions about efficiency.

- Safety/Compliance: Blind cord hazard; no structural risks seen.
- Asset Impact: Addressing blinds and cleaning will improve presentation and buyer confidence.

Material: Wood and glass
Damage: Low

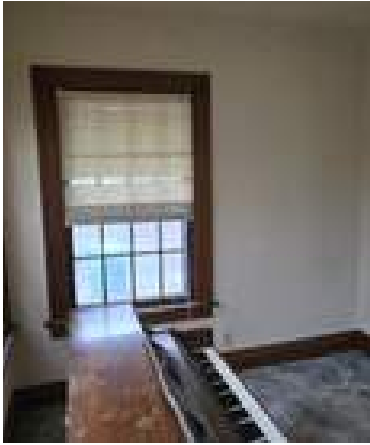
Windows And Trim (Condition Notes)

Fair

Three wood-framed windows are structurally intact and free from cracks or rot. Window frames have minor scuffs and normal wear, particularly around latches and sills. One blind is noticeably uneven, affecting visual presentation. Surfaces need cleaning and minor touch-up to enhance appeal.

- **Safety/Compliance:** No immediate hazards or code deficiencies are visible.
- **Asset Impact:** Cosmetic wear and misaligned blinds may reduce visual value but do not require disclosure.

Damage: Low

Next Action: Clean, realign, or replace blinds; touch up window trim before listing.

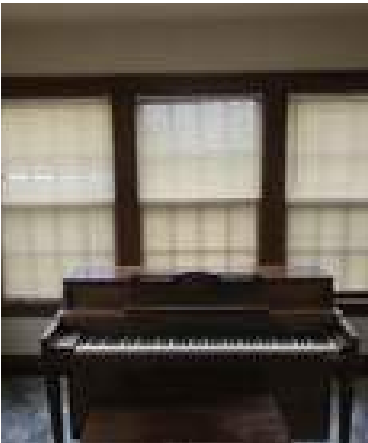
Window Blinds (Condition Notes)

Fair

Plastic blinds are present on all visible windows and several are bent or uneven. No missing parts or hazards, but poor alignment detracts from overall room appeal.

- Safety/Compliance: No risk to safety from existing blinds.
- Asset Impact: Visibly damaged blinds could lower buyer's perceived value.

Damage: Low

Next Action: Replace or realign blinds for optimal presentation.

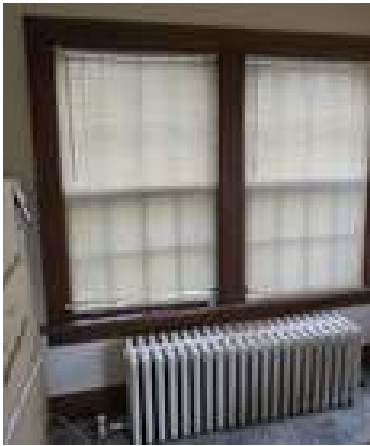
Windows (Condition Notes)

Fair

Three wood-framed windows with horizontal blinds, frames stable and glass intact with no rot or structural issues. Blinds are mismatched and bent, affecting photo appeal; cleaning and straightening will enhance listing quality.

- Safety/Compliance: Structurally sound, no hazards present.
- Asset Impact: Cosmetic blind issues can affect offers but windows don't require repair.

Next Action: Clean windows and repair or update blinds.

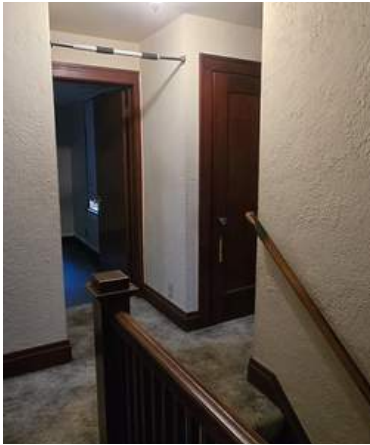
Ceiling (Condition Notes)

Fair

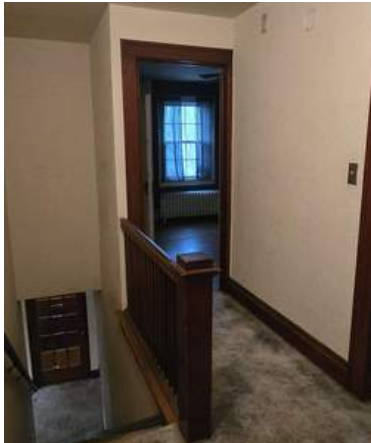
Carpeted Floor (Condition Notes)

Fair

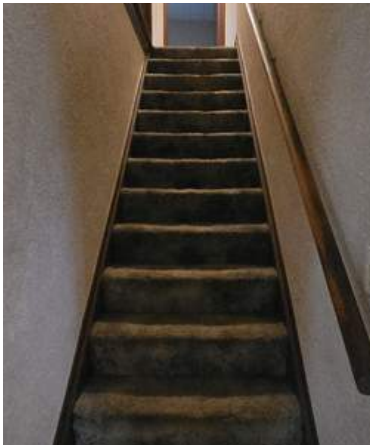
Carpeted Stairs (Condition Notes)

Fair

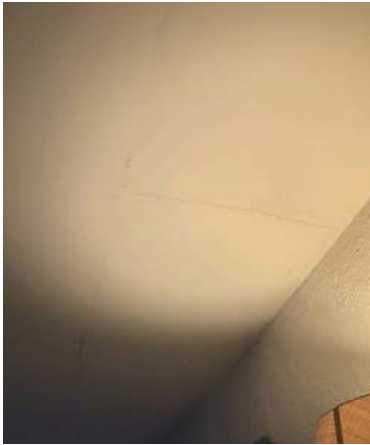
Ceiling Surface (Condition Notes)

Fair

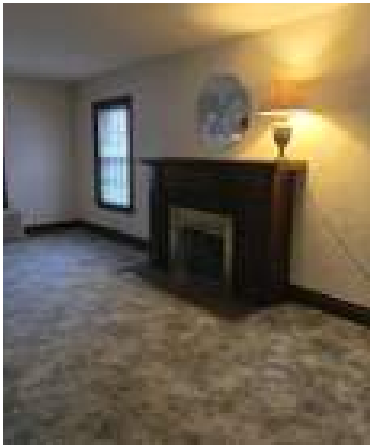
Carpet Flooring (Condition Notes)

Fair

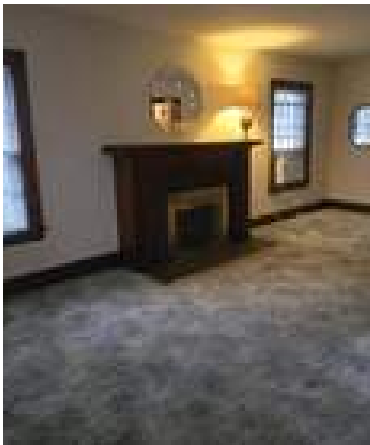
Carpeted Floor (Condition Notes)

Fair

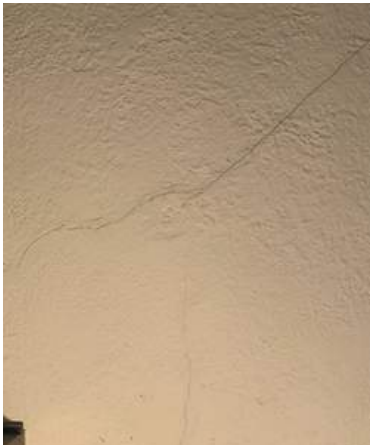
Wall Surface (Key Disclosures)

Fair

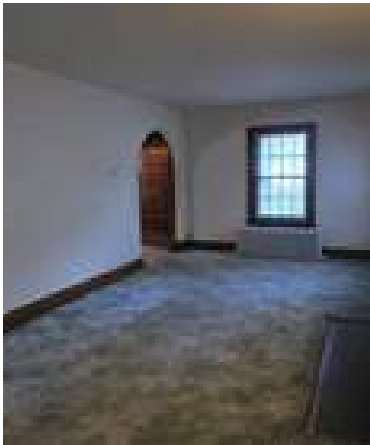
Carpet (Condition Notes)

Fair

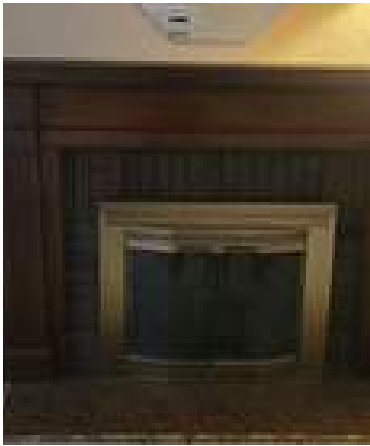
Fireplace Mantel And Surround (Condition Notes)

Fair

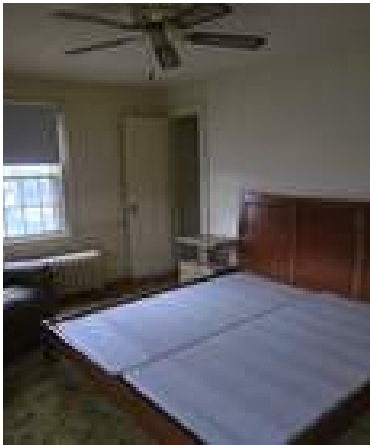
Ceiling (Condition Notes)

Fair

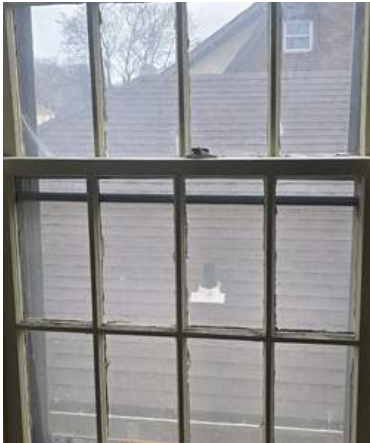
Wood Framed Window (Condition Notes)

Fair

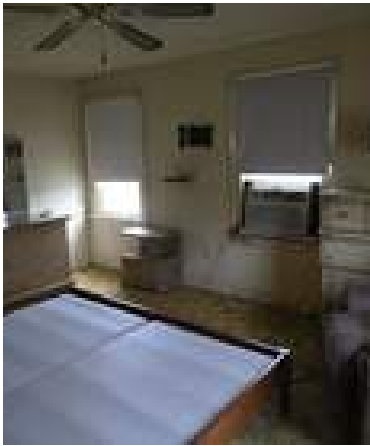
Wall Surfaces (Condition Notes)

Fair

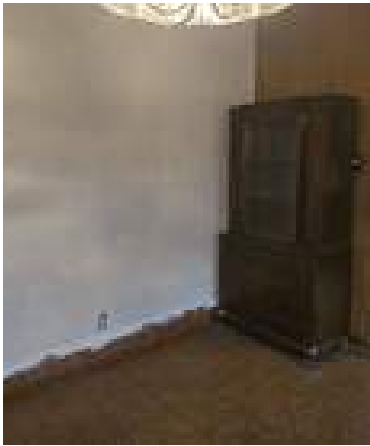
Wall (Key Disclosures)

Fair

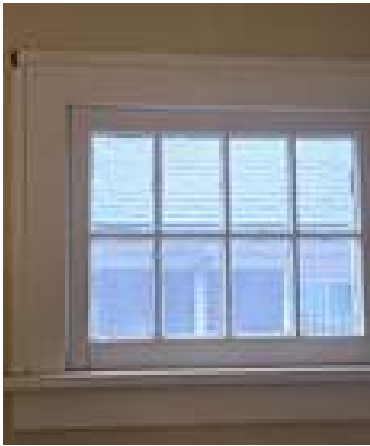
Window (Condition Notes)

Fair

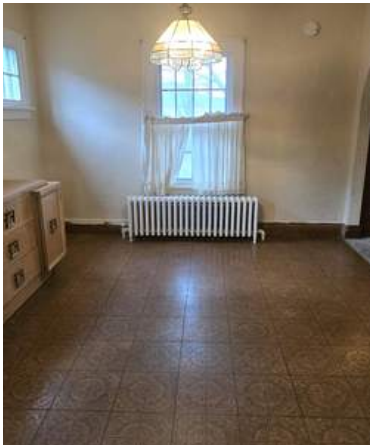
Floor (Condition Notes)

Fair

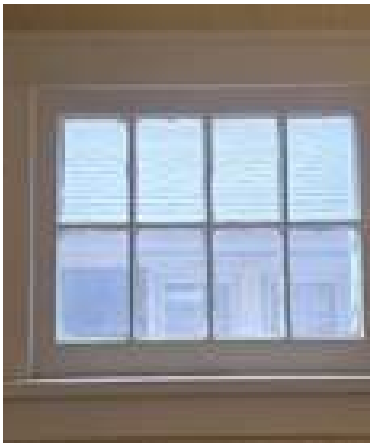
Window (Condition Notes)

Fair

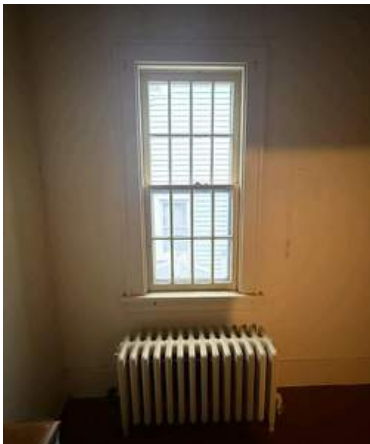
Window (Condition Notes)

Fair

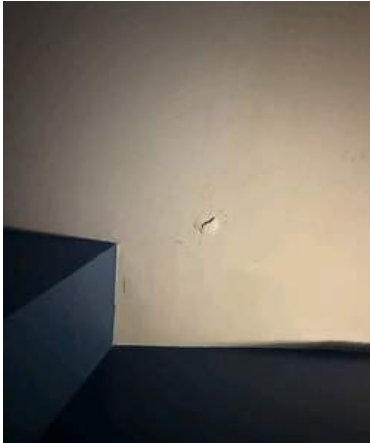
Drywall Surface (Key Disclosures)

Poor

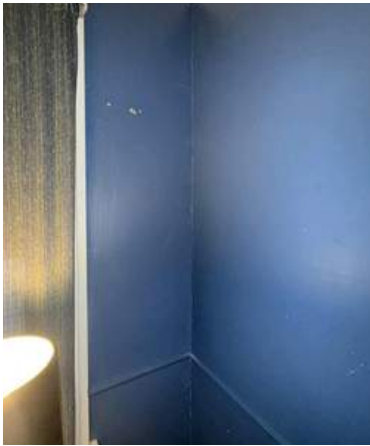
Interior Painted Wall (Condition Notes)

Fair

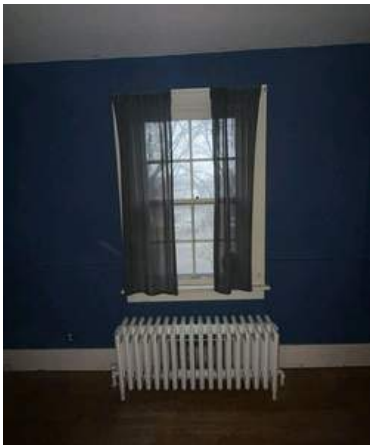
Window (Key Disclosures)

Fair

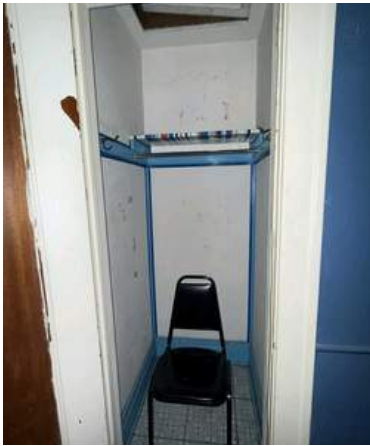
Closet Walls (Key Disclosures)

Fair

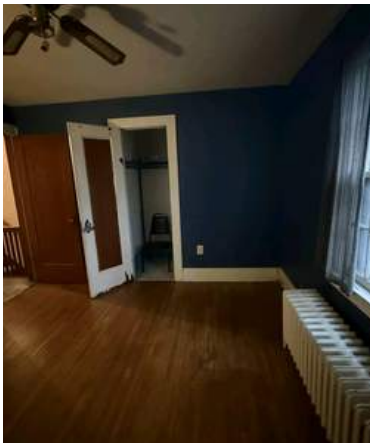
Wood Floor (Condition Notes)

Fair

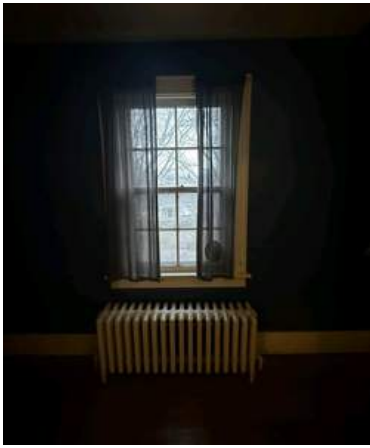
Window (Condition Notes)

Fair

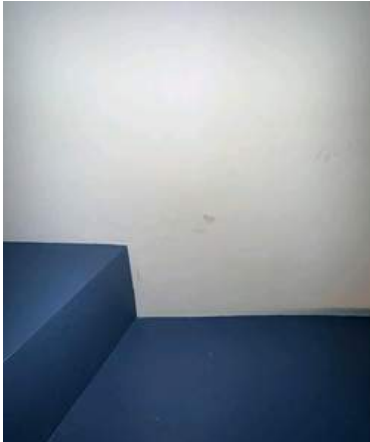
Interior Wall (Condition Notes)

Fair

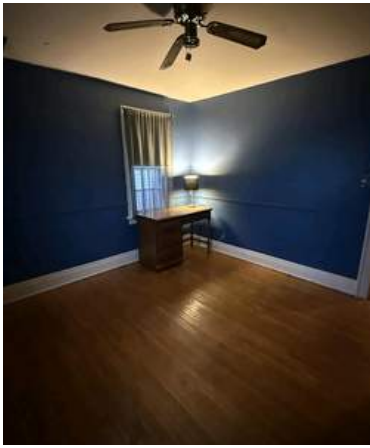
Hardwood Floor (Condition Notes)

Fair

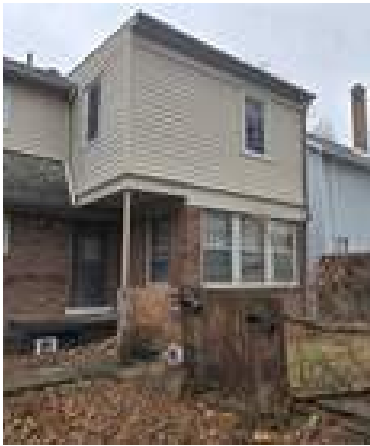
Siding And Brick Exterior (Condition Notes)

Fair

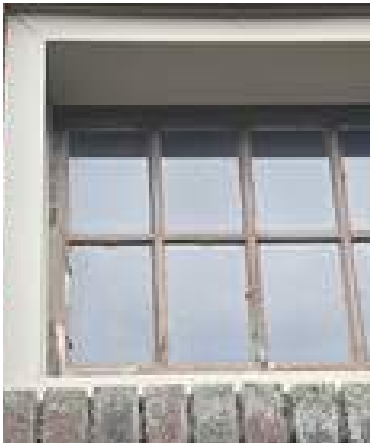
Wood-Framed Window (Key Disclosures)

Poor

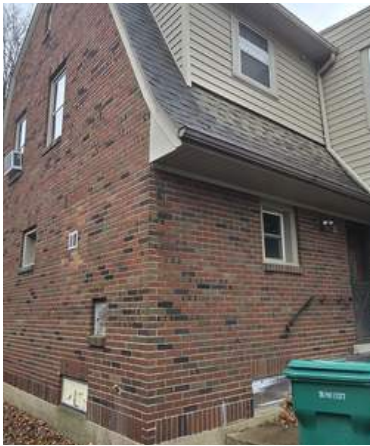
Brick Exterior Wall (Condition Notes)

Excellent

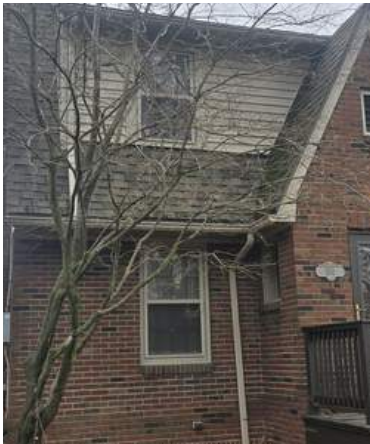
Exterior Siding and Brick (Condition Notes)

Fair

Surface flaws and staining only; brick appears stable, but upper level siding is aged.

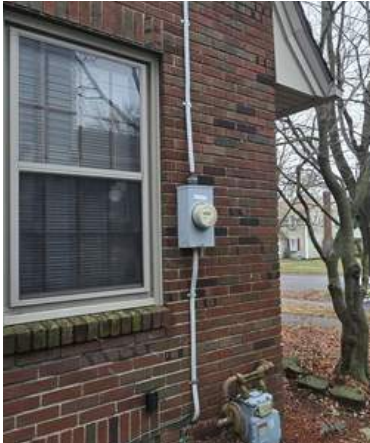
Exterior Electrical Meter and Service Riser (Key Disclosures)

Excellent

Meter and service riser show no visible damage, proper enclosure, and no code violations based on current views. Full ground and interior connections not confirmed.

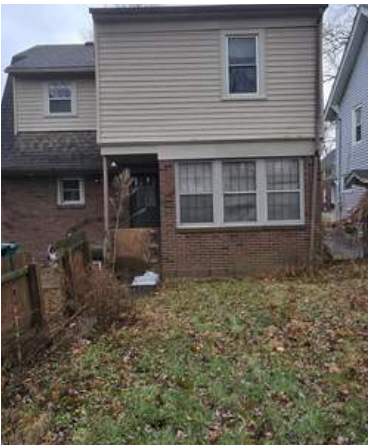
Rear Exterior Brickwork (Condition Notes)

Fair

No cracking visible; only minor moss or dirt present.

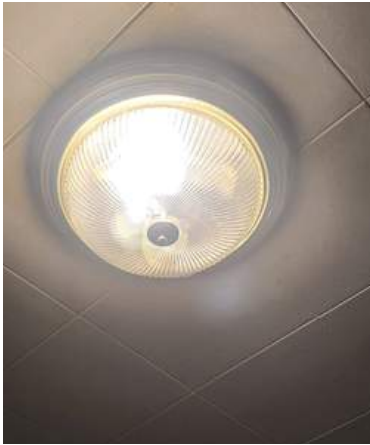
Ceiling (Condition Notes)

Excellent

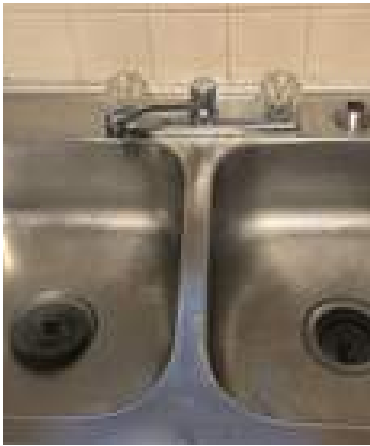
Dual Bowl Sink (Condition Notes)

Fair

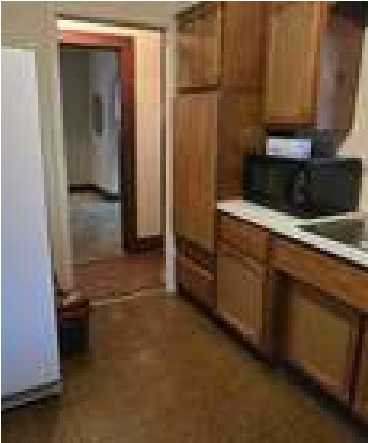
Wood Cabinets (Condition Notes)

Fair

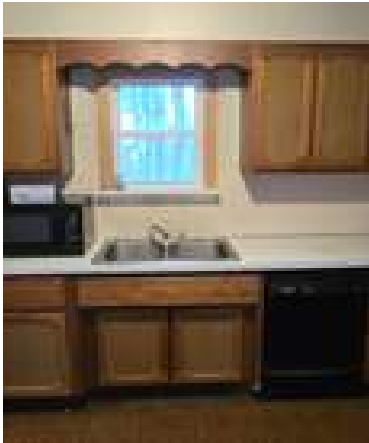
Upper and Lower Wood Cabinets (Condition Notes)

Fair

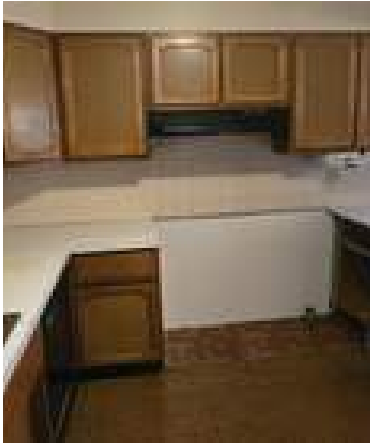
Upper and Lower Kitchen Cabinets (Key Disclosures)

Poor

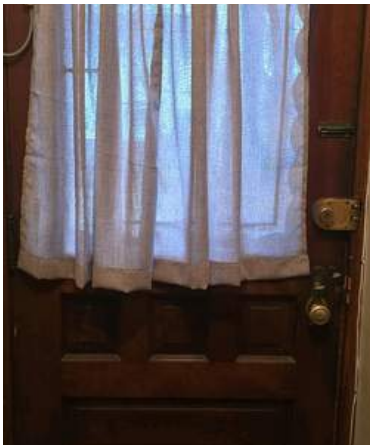
Door Hardware and Locks (Key Disclosures)

Fair

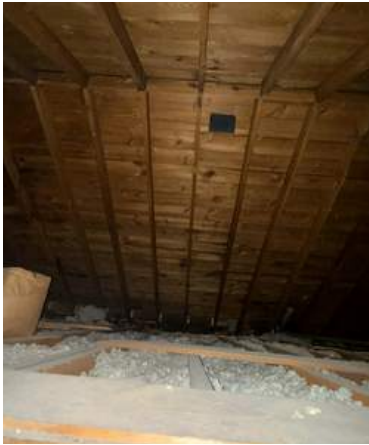
Open Rafter Roof Deck (Condition Notes)

Excellent

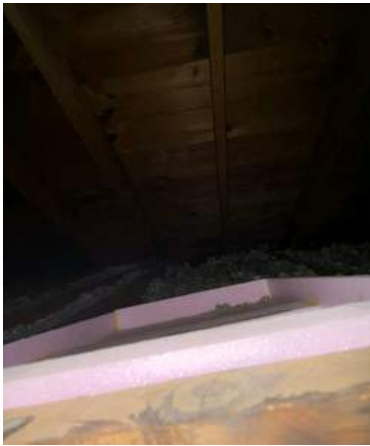
Attic Ceiling (Condition Notes)

Fair

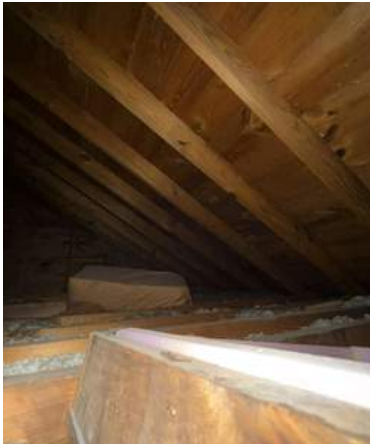
Exposed Rafters And Roof Decking (Condition Notes)

Fair

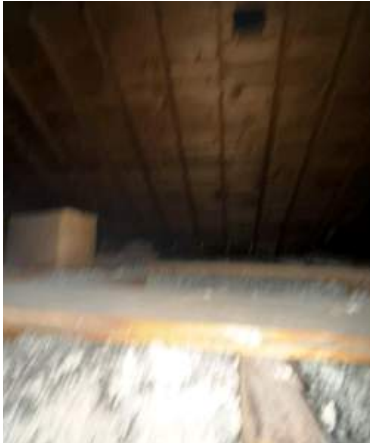
Attic Ceiling (Partial Key Disclosures | Image Incomplete)

Fair

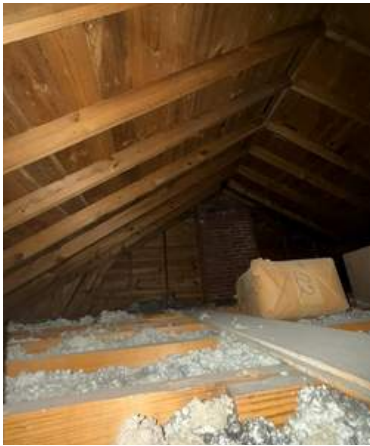
Attic Roof Decking And Rafters (Condition Notes)

Excellent

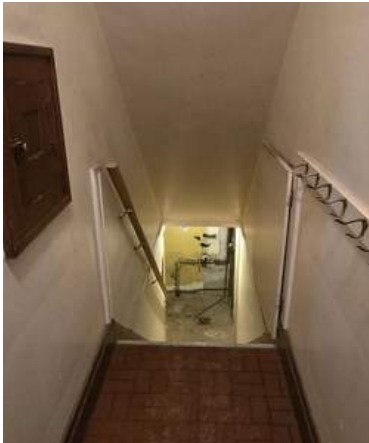
Staircase (Key Disclosures)

Poor

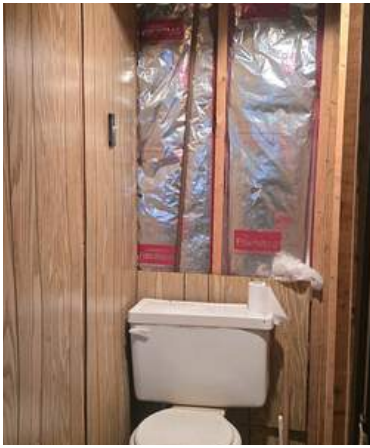
Toilet (Key Disclosures)

Fair

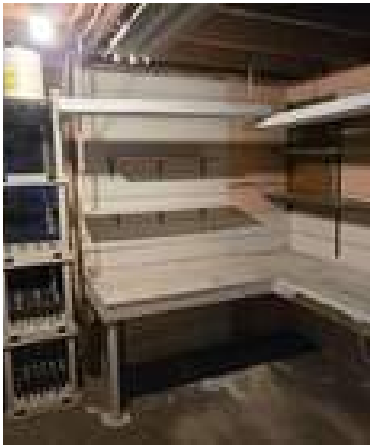
Workbench and Shelving (Condition Notes)

Fair

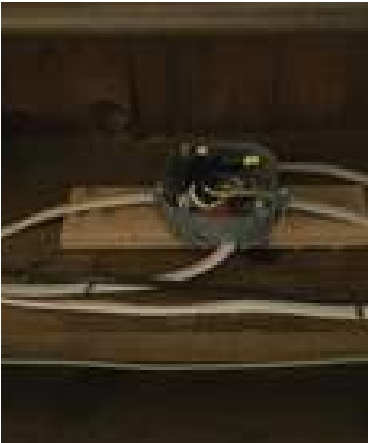
Electrical Wiring (Condition Notes)

Fair

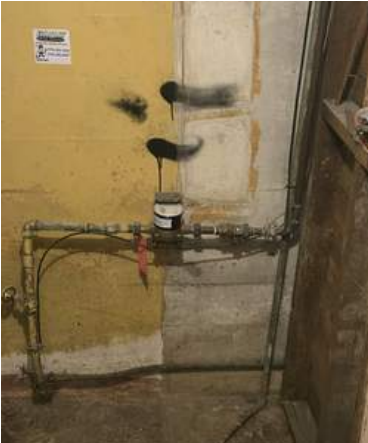
Concrete Basement Wall (Condition Notes)

Fair

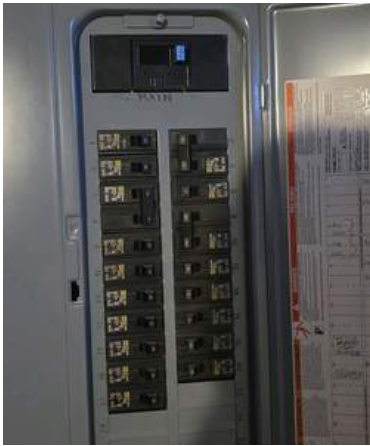
Electrical Panel (Presentation Highlights)

Excellent

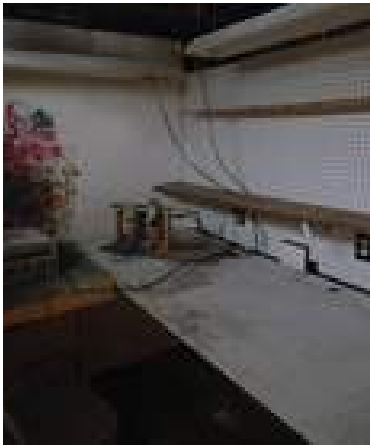
Painted Concrete Wall (Key Disclosures)

Fair

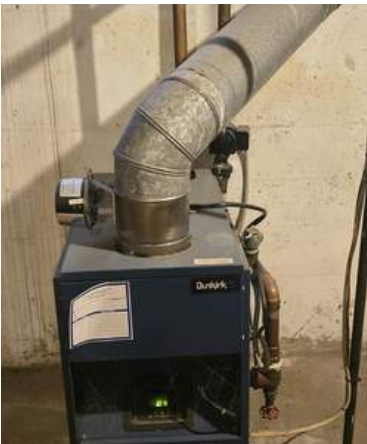
Venting/Ductwork (Condition Notes)

Fair

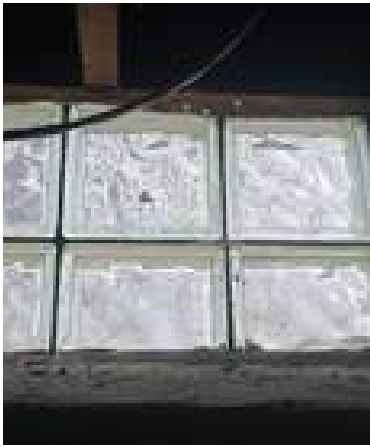
Glass Block Basement Window (Key Disclosures)

Fair

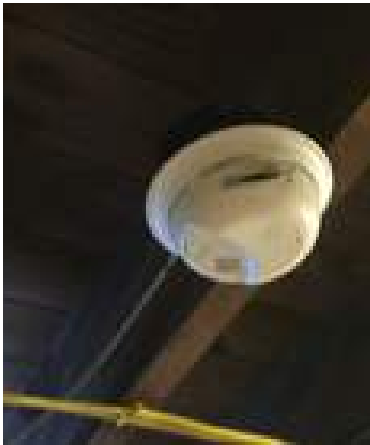
Smoke Detector (Key Disclosures)

Excellent

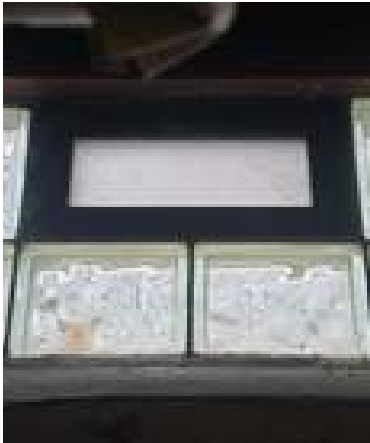
Glass Block Basement Window (Key Disclosures)

Fair

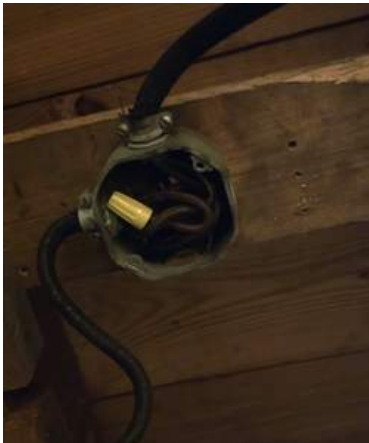
Open Electrical Junction Box (Key Disclosures)

Poor
