Date of Report
20 November, 2025

8113 Frontier Ave. Niagara Falls, NY 14304

INSPECTION BRIEF

This AI-generated summary holistically reviews the property's visible condition for pre-listing preparation and buyer disclosure clarity.

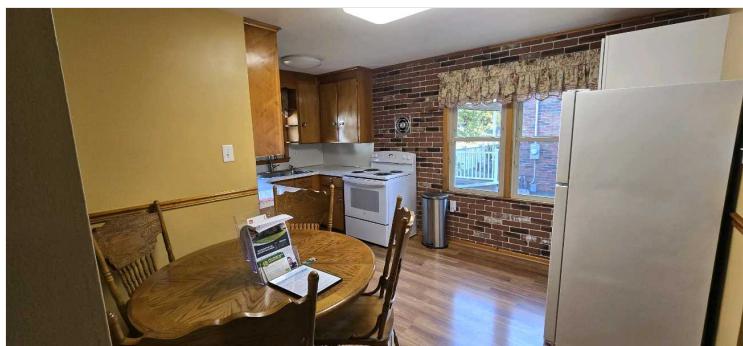
Laminate Floor (Condition Notes)

Laminate flooring throughout the kitchen and dining area appears visually intact with no visible damage, gaps, or significant wear. Uniform finish and stable presentation suggest flooring is suitable as a cosmetic selling point for photography and showings. Routine cosmetic prep may include dust or light cleaning to enhance shine. No tripping hazards or surface irregularities observed; this supports strong buyer confidence and smooth appraisal.

Painted Wall (Condition Notes)

Painted wall in the dining area is fully visible with a uniform color and no distinct stains, visible damage, or cracks. No evidence of patching, holes, or water marks noted; trim is intact. Minor cleaning may be beneficial prior to showings but repainting is not necessary for market readiness. Presents as a routine cosmetic prep item; no disclosure or correction needed for listing.

Single large kitchen window with wood casing and fitted valance. Glass and frame appear clear and undamaged; no condensation, cracks, or evidence of failed seals observed. Window is free of obstruction and provides ample natural light for photography. Routine cleaning of the sill or glass may further enhance presentation. No barriers to egress or insurance/appraisal risk identified.

Cabinets (Condition Notes)

Wood kitchen cabinets visible along the back and side wall; finish is intact with consistent surface coloration and no visible warping, broken doors, or missing hardware. Minor wear may be present on edges but not apparent in this view. No immediate repair or disclosure needed; light routine cleaning or polishing could improve photo appeal.

White electric range/oven is present and visually clean from this angle with no staining, missing parts, or readily visible damage. Controls, cooktop, and oven door are intact. Standard appearance supports marketability; routine wiping before showings recommended. Disclose only presence and visible condition, not function or age.

Ceiling Light Fixture (Condition Notes)

Ceiling-mounted light fixture centered in the kitchen. Dome is intact with no visible cracks or stains; fixture is securely mounted. No exposed wiring or discolored ceiling surrounding the light. Preparation for listing may include ensuring fixture is clean for best presentation, but no correction or disclosure needed based on current visible state.

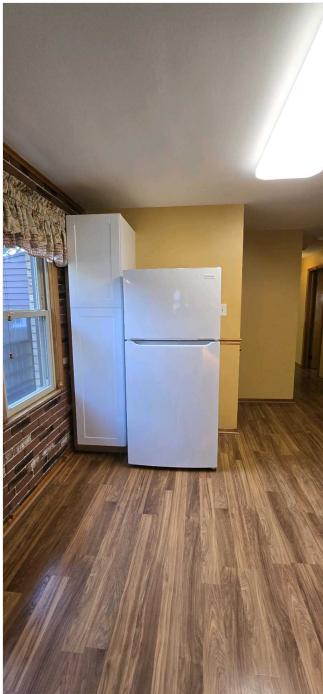
Laminate Flooring (Condition Notes)

Wood-look laminate flooring is fully visible, with no clear evidence of damage, staining, warping, or significant scratches in the photographed area; finish appears intact and uniform. Routine cosmetic prep cleaning before photography may enhance shine and first impression, but no corrective work is visibly necessary. Supports positive appraisal and buyer perception; low anticipated cost, marketability strength.

Painted Walls (Condition Notes)

Painted drywall in soft yellow tone; visible portion appears clean and free of scuffs, peeling, or holes. Supports first impression in photos; only touch-up cleaning recommended for optimal presentation. Cosmetic prep item only; no evidence of CapEx or inspection risk in this area. Enhances buyer confidence regarding upkeep.

Ceiling (Condition Notes)

Flat painted ceiling visible above main flooring area; no clear stains, cracks, or evidence of moisture. Surface looks consistent with no visible need for patching or repainting. Cosmetic only; supports showing readiness and appraisal review. No reservation regarding habitability or code.

Single window with wood trim and decorative valance; trim and sill in good visible repair no chipping, rot, or water stains present. Glass appears intact and clear without cracks. Presents well in photos and showings, with no corrective work needed. Routine cleaning advised before photography for best effects, but this is a selling point feature.

Interior brick accent wall section visible behind cabinetry; no evidence of mortar loss, major staining, or structural deficiency. Stable and visually attractive element favoring listing photographs and buyer impression. No prep beyond dusting required.

Cabinetry (Condition Notes)

Tall white built-in cabinet adjacent to refrigerator; doors appear closed properly and surface is unmarred and clean in current view. No evidence of finish damage or hardware defects. Cosmetic cleaning for optimal presentation is sufficient; no repair or disclosure need.

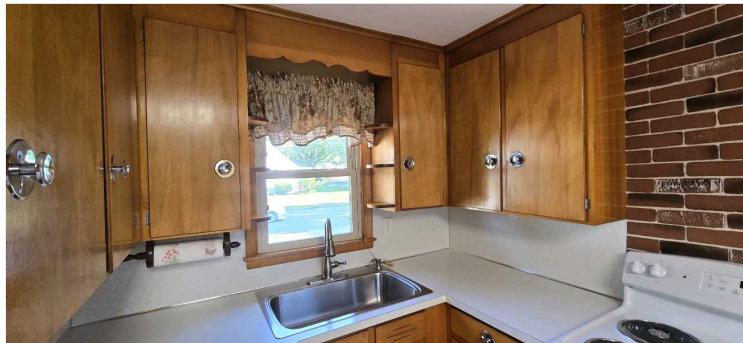
Sink Area (Condition Notes)

Stainless steel sink basin and faucet; sink and surrounding countertop appear clean with no visible staining, cracking, or evidence of leaks; metal faucet and escutcheon show no discoloration, corrosion, or visible damage; drain area intact and unobstructed. This condition improves listing photos and supports positive buyer perception, with no visual indicators requiring correction or disclosure. Routine cosmetic prep is sufficient.

Wood cabinets and window trim finished in natural stain; cabinet doors and hardware intact and aligned, with no visible warping, paint loss, or water staining. Surface condition presents as clean and well-cared for, enhancing first impression for buyers and photographs. No known risk to inspections or appraisals; this is a listing strength. Routine dusting and cleaning recommended prior to photography.

Countertops And Backsplash (Condition Notes)

Laminate countertops and backsplash; surfaces visibly free of burn marks, major scratches, chips, or water damage. Edges and seams appear tight and undamaged. Surfaces present as clean for photography and showings, with no material deficiencies impacting listing or disclosures. Cosmetic prep only as needed.

Electrical Outlet (Condition Notes)

One visible wall outlet above the countertop between sink and stove; cover plate is present and intact, showing no signs of yellowing, cracks, or exposed wiring. Listing readiness is fully supported, as there are no visible electrical safety risks or code issues. Visual condition is satisfactory for market preparation.

Double-hung window above the sink with intact glass panes; wood trim in sound visual condition, free of paint chipping, water staining, or frame deterioration. Window provides good natural light and is an asset for showings. Cosmetic cleaning of glass for photography is recommended.

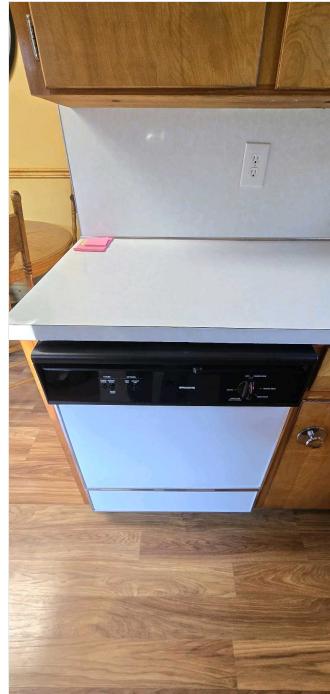
Dishwasher (Condition Notes)

Built-in dishwasher; exterior front is visibly clean with no scratches, dents, or discoloration; control panel is intact with all physical knobs and buttons present; no visible signs of leakage, corrosion, or staining at base or seams; demonstrates a well-maintained appearance. This is a routine cosmetic prep item; does not represent a listing blocker but should be kept clean for photographs and showings as dated styling may affect buyer perception slightly; disclosure of vintage may be prudent if inquired, but no visible defects requiring advance correction or concession.

Wood upper and lower cabinets; doors appear properly aligned and undamaged; natural wood finish with no visible cracks, peeling, or significant wear; consistent color and sheen supports positive first impression in photos and showings. This condition is a selling point for marketability, requiring only standard cleaning and touch-up prior to listing.

Laminate countertop; surface is smooth and free from chips, burns, staining, or separation at edges; clean appearance supports strong presentation for listing photography and buyer showings; no visible maintenance or disclosure needs.

Electrical Outlet (Condition Notes)

Single duplex outlet above counter; cover plate securely installed with no cracks, chipping, or exposed wiring visible; visually complete and meets photo-ready standards; cosmetic cleanliness supports favorable buyer impression, though ingress protection (GFCI) is not verified from image and should be disclosed if non-compliant after closer inspection; not a visible safety risk.

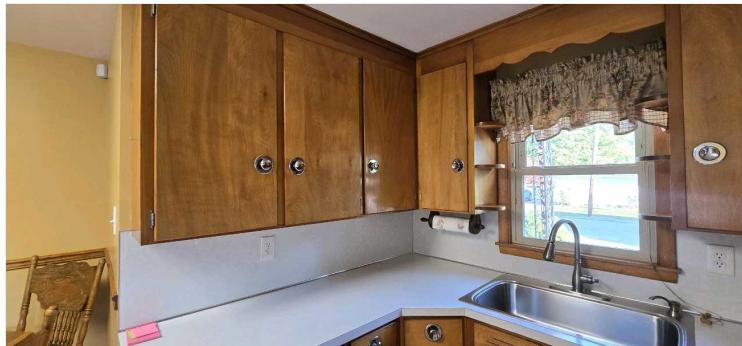
Cabinetry (Condition Notes)

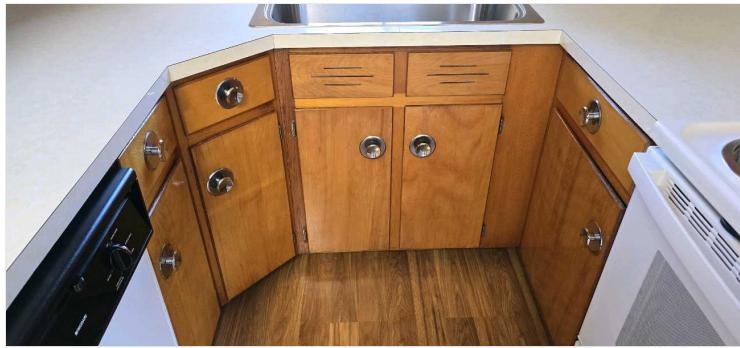
Base Cabinets (Condition Notes)

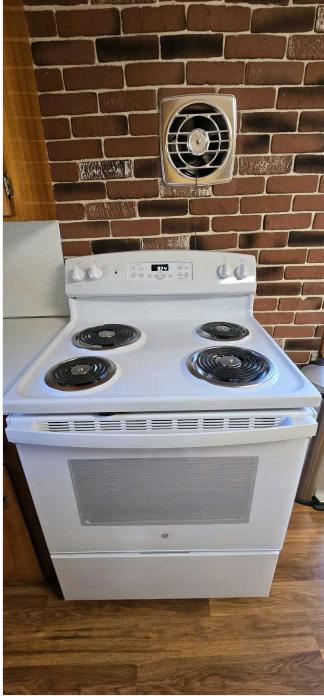
Electric Stove And Oven (Presentation Highlights)

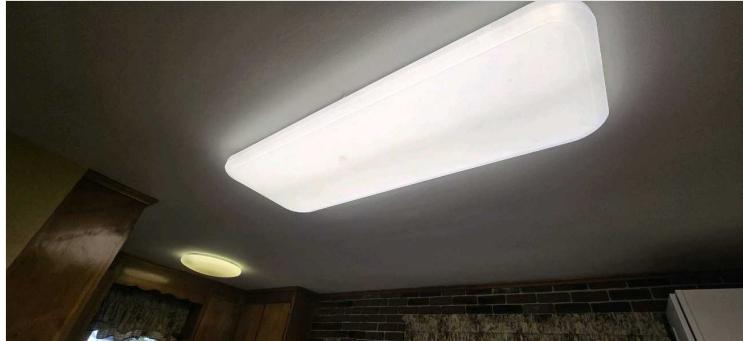
Ceiling (Condition Notes)

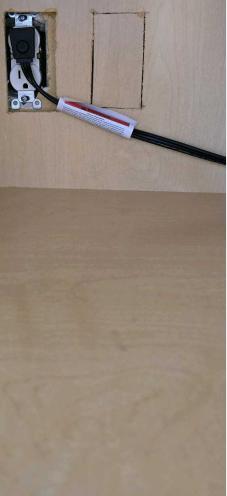
Electrical Outlet (Key Disclosures)

Standard duplex electrical outlet; electrical outlet cover plate missing and wiring exposed within cabinet cutout; no clear evidence of charring or staining; edges of wood cut roughly, with surrounding cabinet surface unprotected. This exposed configuration presents both a code compliance and safety issue, likely to draw negative attention in inspection, appraisal, and showings. Correction is advised prior to professional listing photography and property tours to avoid insurance or lender delays and reduce buyer concern. Labeled as a priority disclosure and correction item for transparent listing preparation; cover replacement is a low-cost, high-ROI routine maintenance action, but current state is a listing blocker.

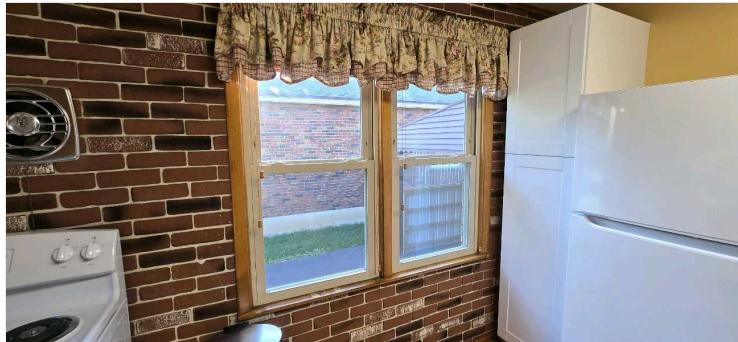
Double Window Unit (Condition Notes)

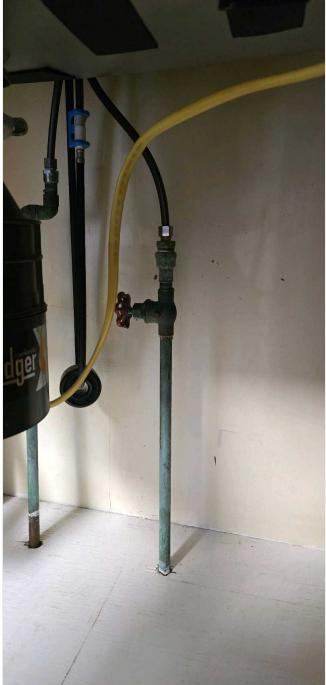
Exposed Water Shutoff Valve And Supply Pipes (Key Disclosures)

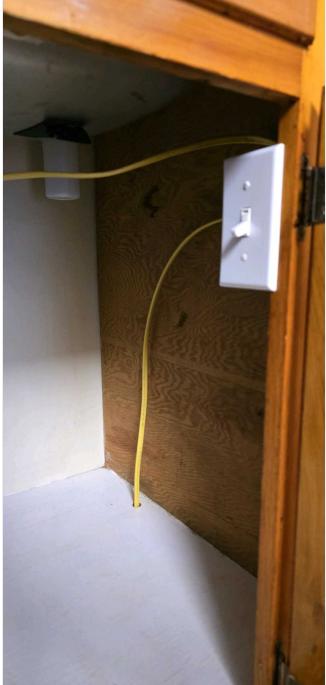
Wall Switch And Unsecured Electrical Cable (Key Disclosures)

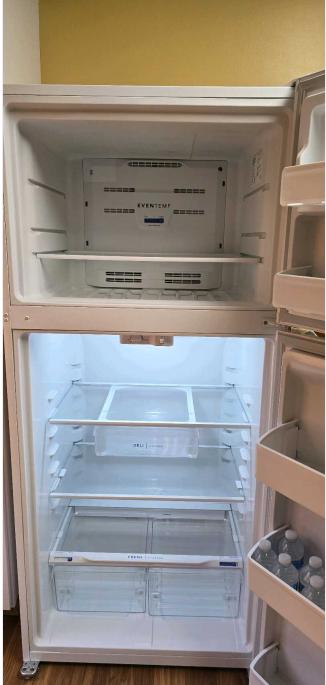
Refrigerator-freezer (Presentation Highlights)

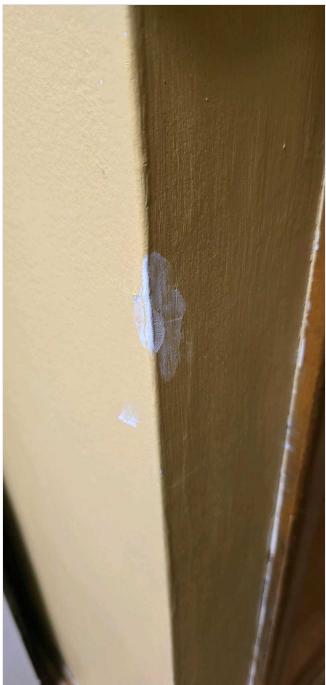
Wall Corner (Condition Notes)

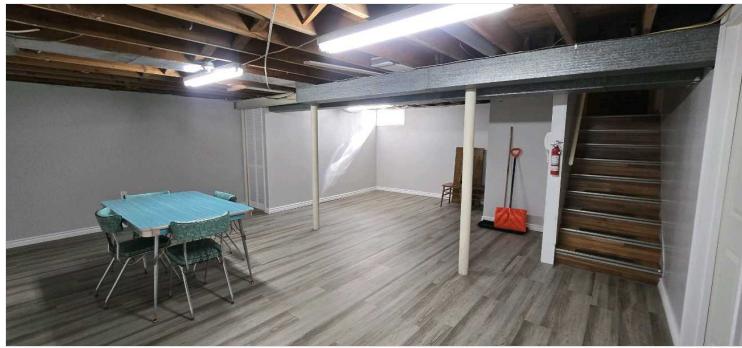
Exposed Basement Ceiling (Key Disclosures)

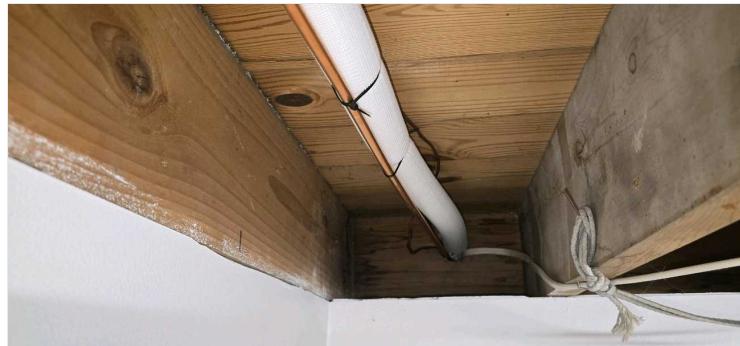
Exposed Ceiling Joists And Framing (Condition Notes)

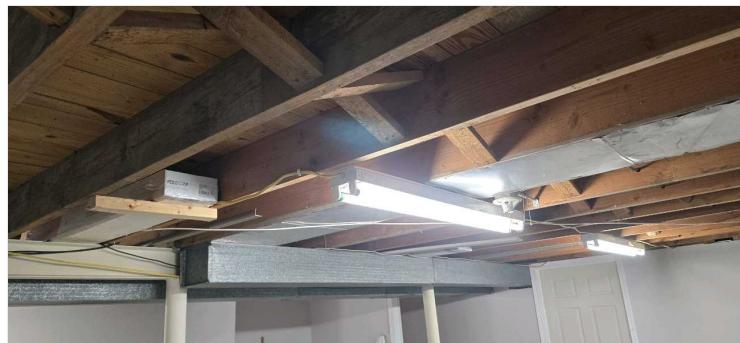
Exposed Floor Joists And Subfloor (Key Disclosures)

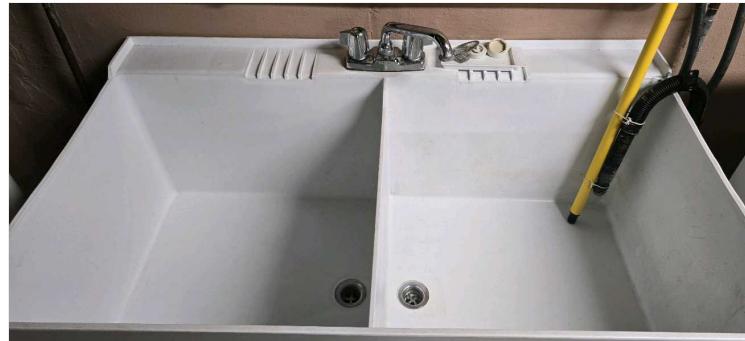
Laundry Sink (Condition Notes)

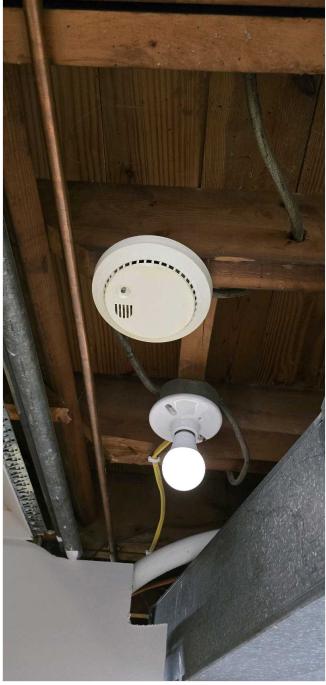
Smoke Detector (Key Disclosures)

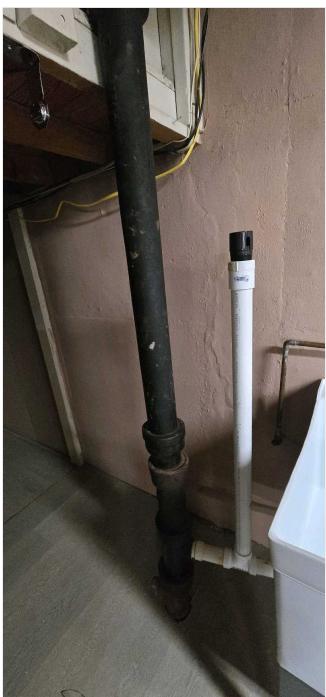
Cast Iron Drain Pipe (Condition Notes)

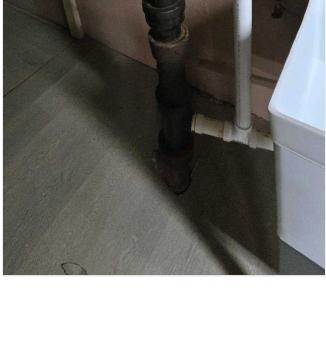
Pvc Standpipe With Air Admittance Valve (Presentation Highlights)

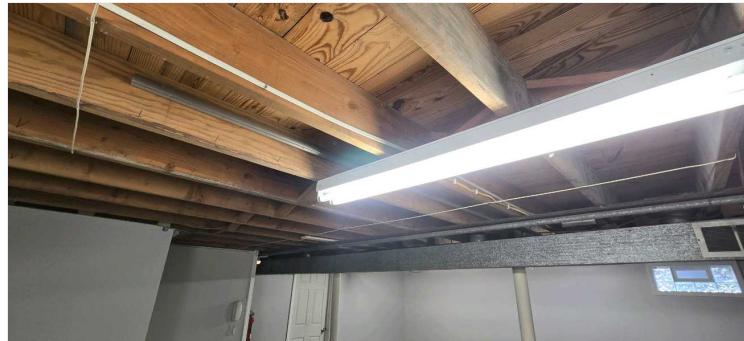
Exposed Wood Joist Ceiling (Key Disclosures)

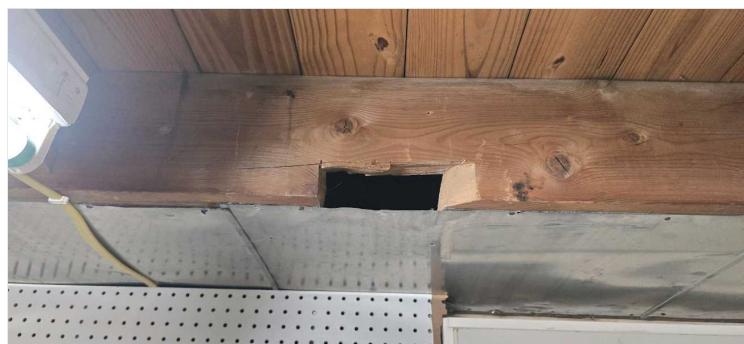
Wood Beam (Key Disclosures)

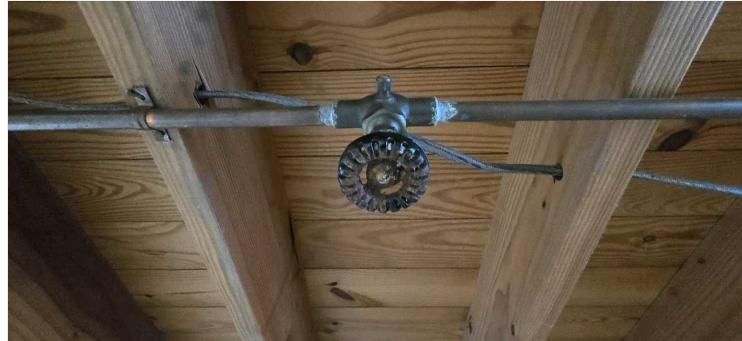
Sprinkler Head (Key Disclosures)

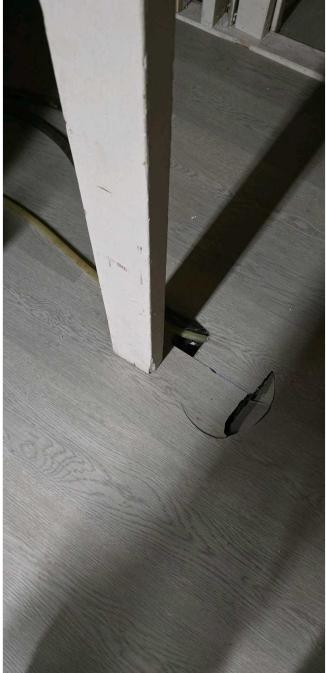
Laminate Floor (Key Disclosures)

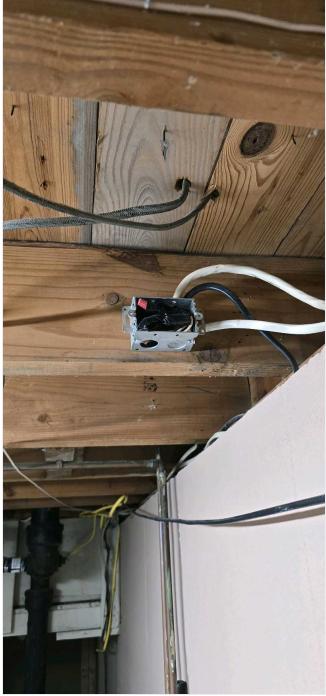
Exposed Electrical Box (Key Disclosures)

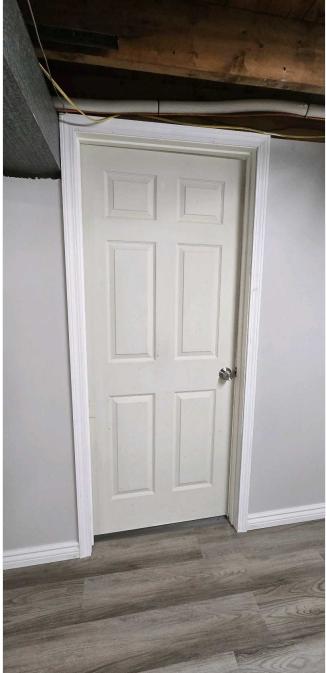
Interior Door (Condition Notes)

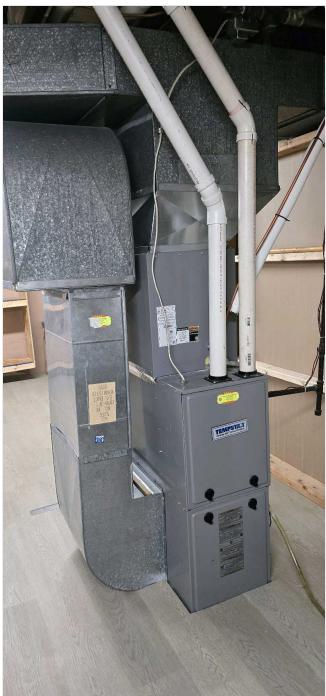
Furnace And Ductwork (Presentation Highlights)

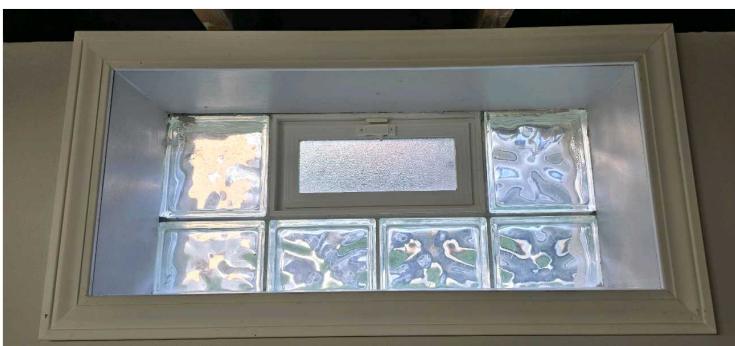
Glass Block Window With Hopper Vent (Presentation Highlights)

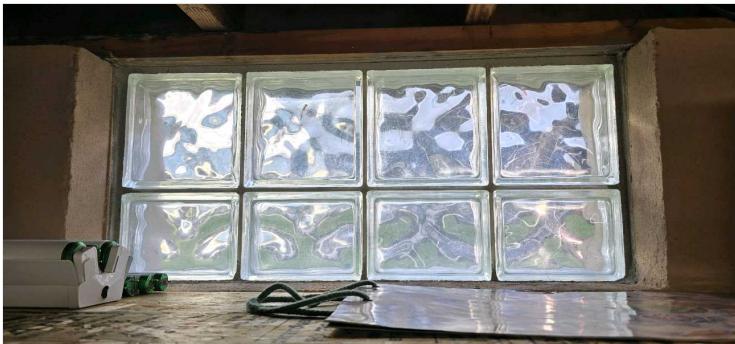
Glass Block Basement Window (Condition Notes)

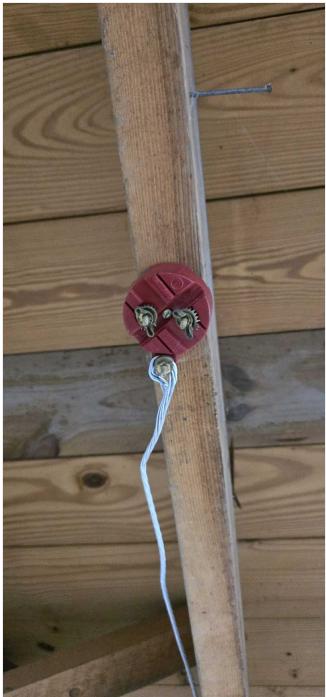
Exposed Ceiling Electrical Connection (Key Disclosures) RED

Safety/Compliance: Live, uncovered ceiling wire terminal immediate fire/shock/code violation; insurance/appraisal will reject.

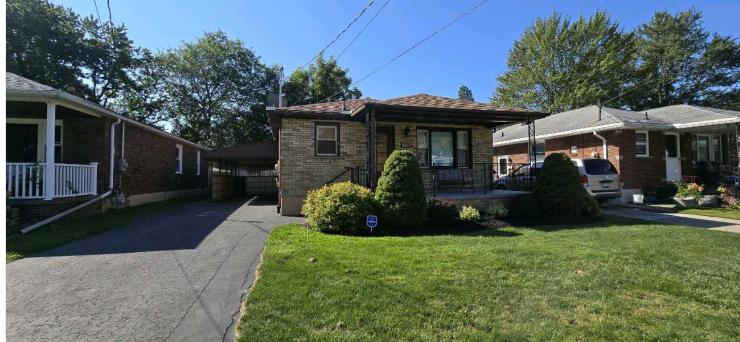
Roof (Condition Notes)

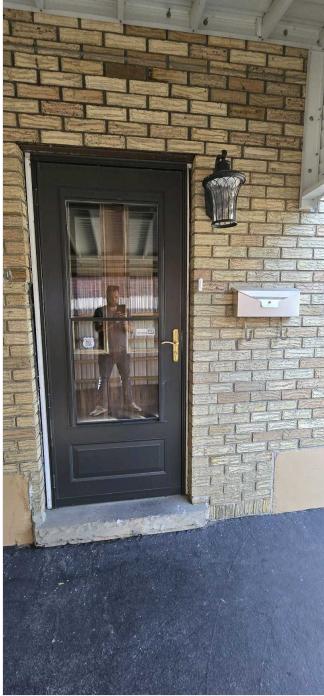
Exterior Glass Door (Condition Notes)

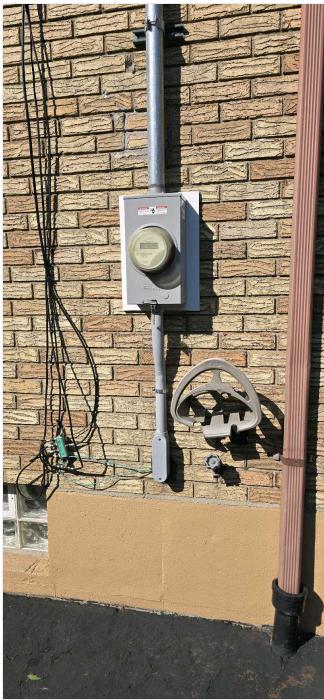
Electrical Meter Panel (Condition Notes)

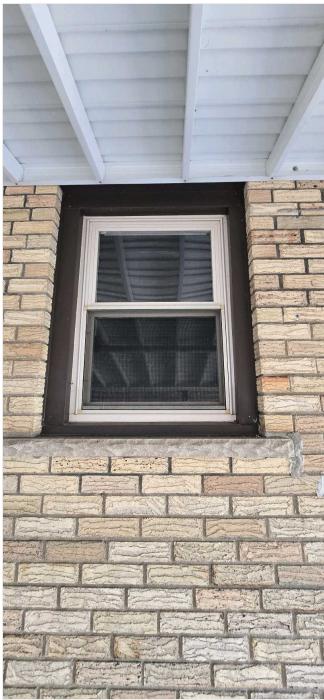
Window (Condition Notes)

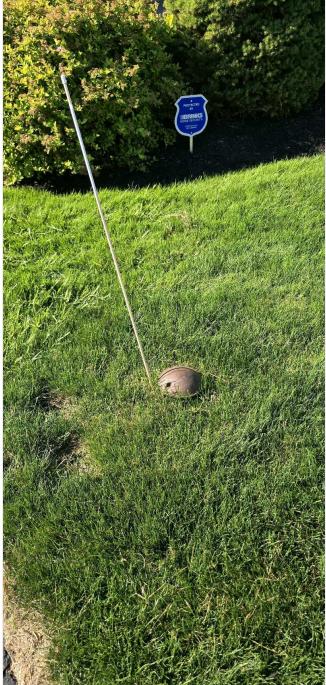
Metal Stake With Utility Cap (Key Disclosures)

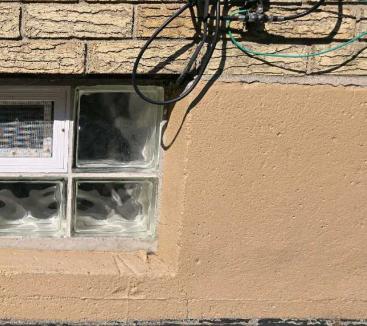
Basement Glass Block Window (Condition Notes)

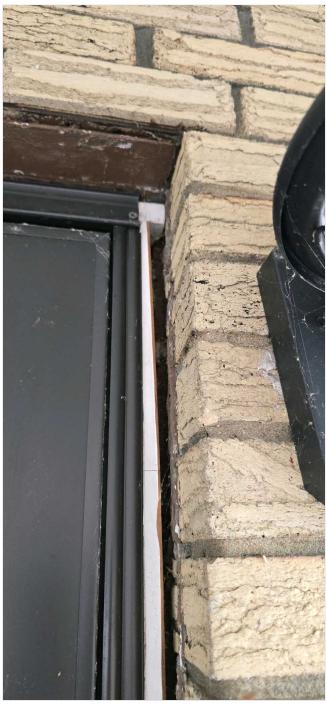
Door Surround (Key Disclosures)

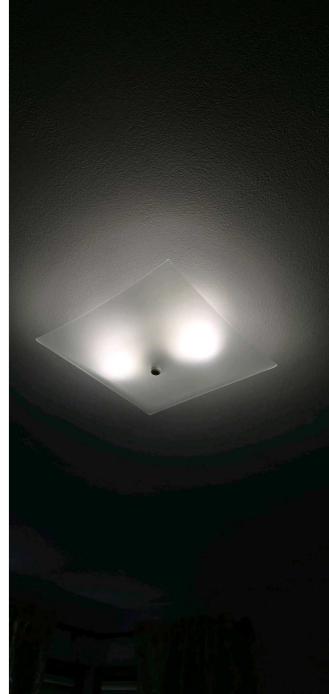
Ceiling Surface (Condition Notes)

Textured ceiling surface; uniform color and finish throughout the visible area; no cracks, stains, water marks, or peeling detected. Condition is consistent with diligent cosmetic upkeep.

Material: Textured drywall/plaster Damage: Low

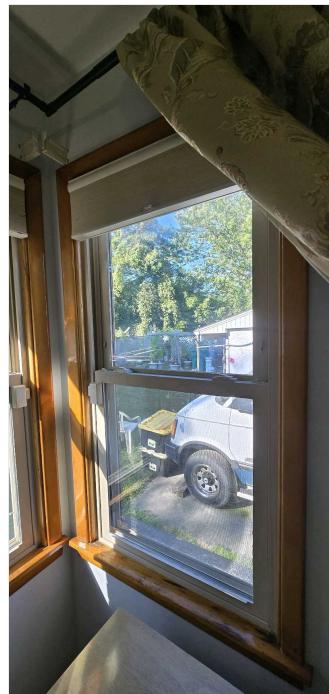
Double-hung Window (Condition Notes)

Vinyl/aluminum frame and wood-trimmed window; glass intact, no fogging or broken seals. Trim has high-gloss finish and minor scuffs on sill. Locks and rails present, curtain/blind hardware mounted securely.

Safety/Compliance: No window egress, lock, or code violations evident.

Material: Vinyl/Aluminum frame, wood trim, glass pane Damage: Low

Marketability & Asset Impact: Touch-up of wood trim/sill recommended for photos; not required for code/financing.

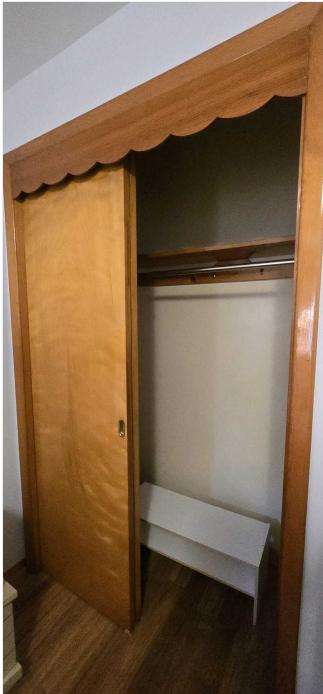
Closet Door (Condition Notes)

Wood sliding closet door, matching surround; no cracks or hardware problems; surface has minor marks and aging. Alignment is good; no panels missing.

Material: Wood Damage: Low

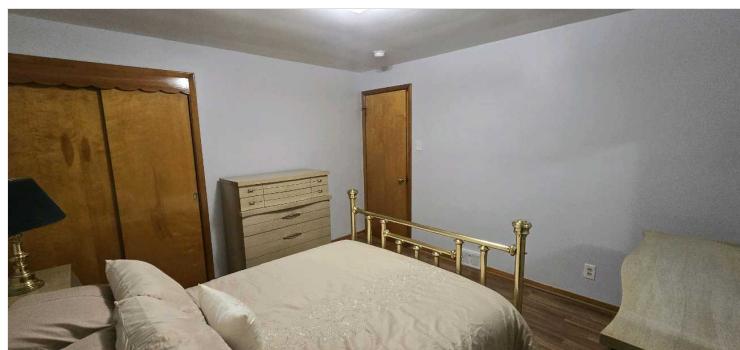
Painted Walls (Condition Notes)

Walls recently painted, smooth and uniform; no visible defects or damage, supports high buyer confidence.

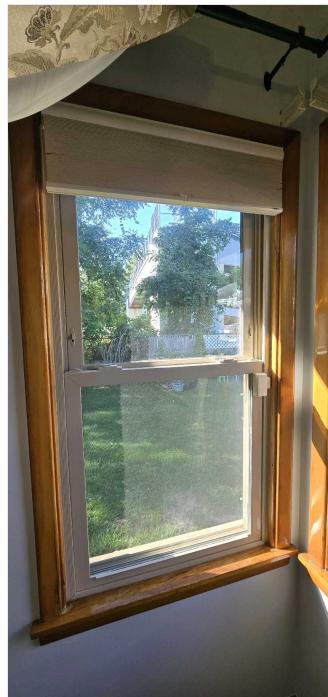
Vinyl Double-hung Window (Condition Notes)

Material: Vinyl and glass Damage: Low

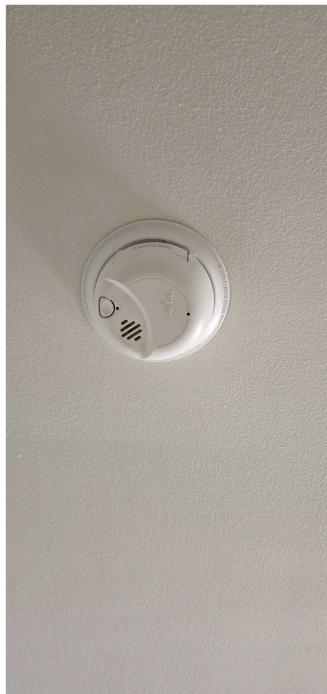
Ceiling-mounted Smoke Detector (Presentation Highlights) GREEN

Ceiling-mounted smoke detector present, intact, and properly secured; no missing or damaged parts.

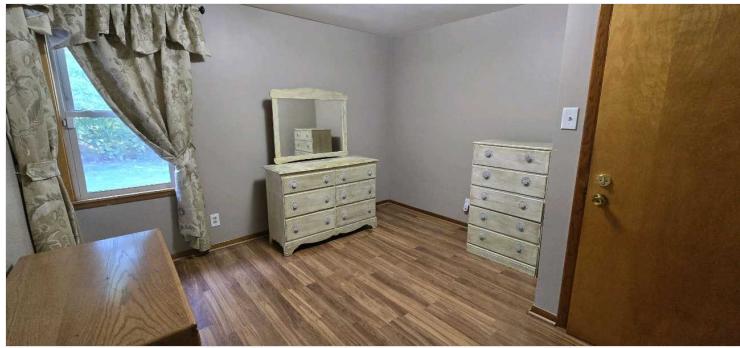
Laminate Floor (Condition Notes)

Laminate flooring; no scratches, stains, or gaps.

Safety/Compliance: No visible hazard.

Next Action: No repair or disclosure surface cleaning only.

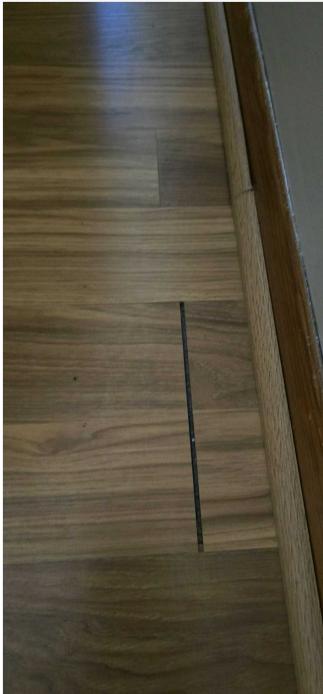
Laminate Flooring (Key Disclosures)

Safety/Compliance: Not tripping hazard but visible flaw.

Material: Laminate or engineered wood Damage: Medium

Safety Risk: Low Priority: Priority

Next Action: Repair immediately before photos/showings or disclose if not fixed.

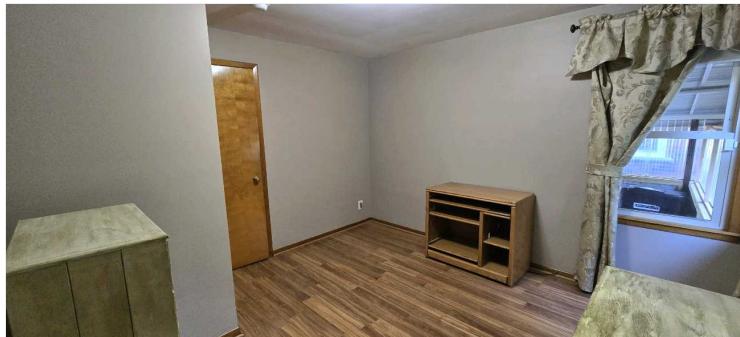
Laminate Flooring (Condition Notes)

Laminate floor planks, surface intact, clean, and free of defects.

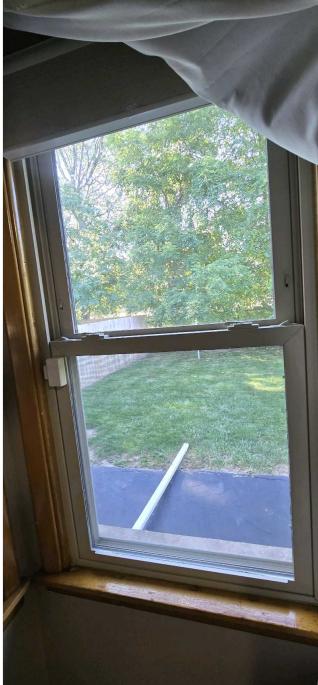
Window (Condition Notes)

Safety/Compliance: No egress or hazard observed.

Marketability & Asset Impact: Sill wear will be visible in close-up photos; low-cost repaint advised.

Material: Vinyl frame; glass pane; wood sill Damage: Low

Next Action: Repair or disclose as minor blemish.

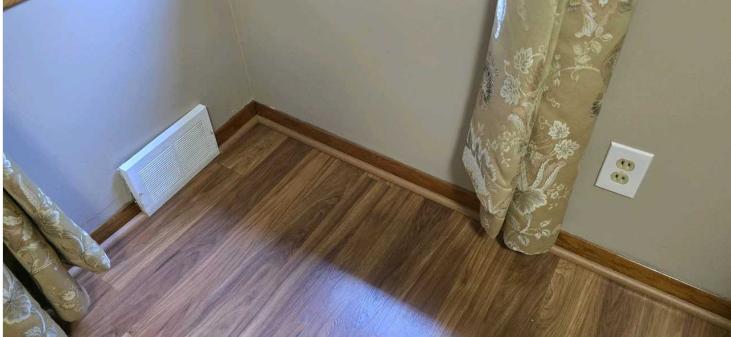
Laminate Floor (Condition Notes)

Corner laminate floor; no cracks/gouges/warping; even and stable.

Safety/Compliance: No hazards.

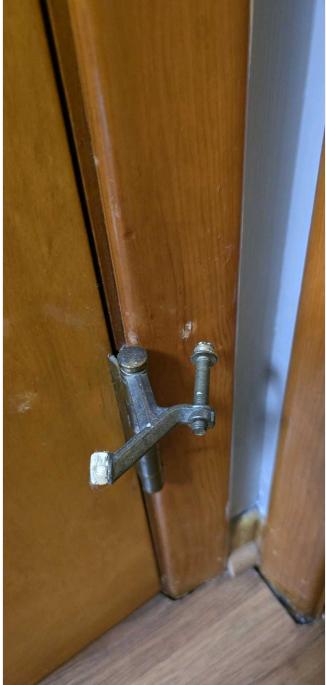
Wooden Door And Door Stopper (Condition Notes)

Wood door with door stopper, edges/scuffs and hardware wear visible; surface blemishes only.

Material: Wood (door), metal (stopper/hardware) Damage: Low

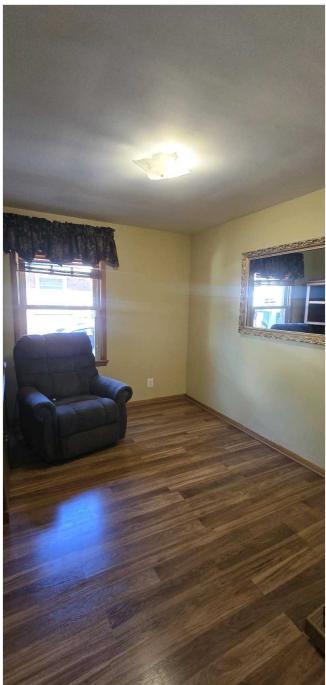
Ceiling (Key Disclosures)

'Safety/Compliance:' Broken cover on light fixture presents minor safety concern (risk of exposed edges or bulb access); could affect lender/insurance review. Visual proof will require repair or disclosure for code and buyer confidence.

'Marketability & Asset Impact:' Damage draws the eye in photographs and will likely prompt negative feedback on showings, threatening perceived care and value; routine maintenance, not a high capital cost, but a primary objection if unaddressed.

Material: Drywall (ceiling), Glass/Plastic (fixture cover) Damage: Medium

Safety Risk: Low Priority: Priority

'Next Action:' Priority repair or replacement before photography and showings; if not fixed, must disclose defect to maintain transparency and avoid last-minute concessions.

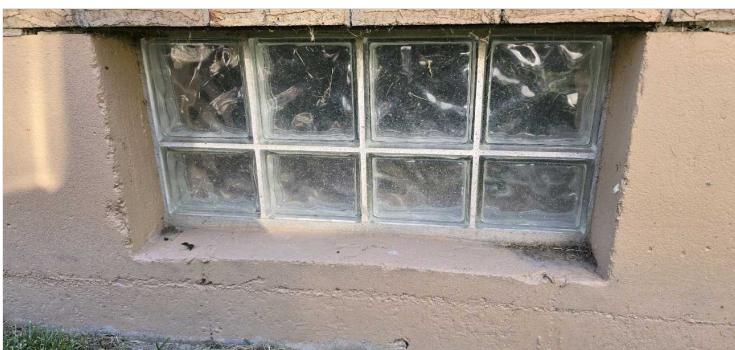
Glass Block Basement Window (Condition Notes)

'Safety/Compliance:' Weathered paint and surface dirt; no water infiltration/structural concerns evident.

Material: Glass block with masonry and painted concrete Damage: Low

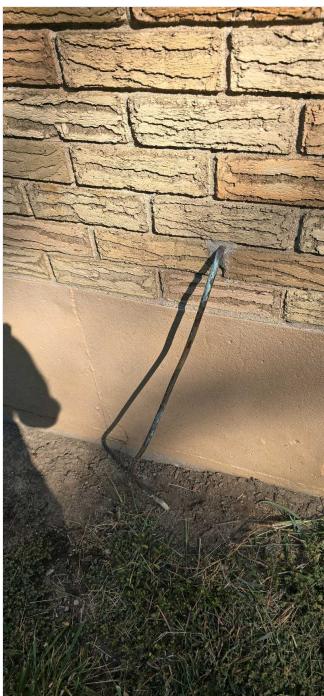
Exposed Wire/conduit (Key Disclosures)

'Safety/Compliance:' Severe safety/code risk weathered, corroded, unprotected wire/conduit at grade.

Material: Metal (possibly copper or steel wire/conduit; insulation condition unclear) Damage: High

Safety Risk: Severe Priority: Urgent

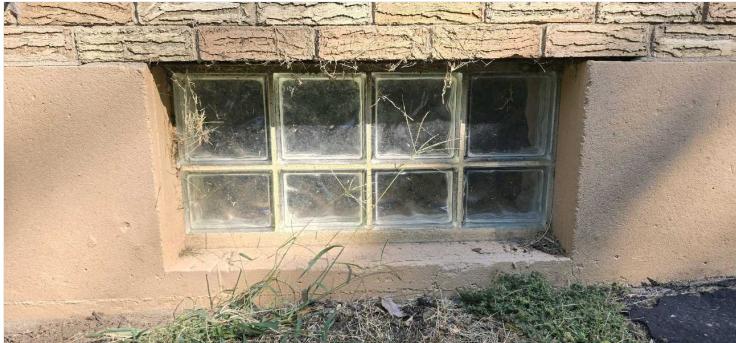
Glass Block Window (Condition Notes)

'Safety/Compliance:' No cracked panes; clean off debris/plant buildup for accurate assessment.

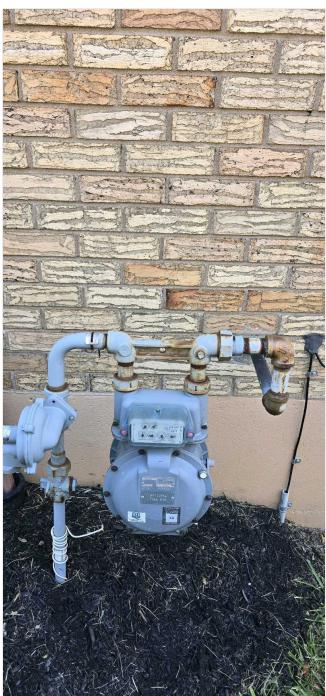
Exposed Gas Meter And Piping (Key Disclosures)

'Safety/Compliance:' Moderate corrosion at pipe joints; surface rust may prompt buyer/appraiser concern.

Material: Steel piping, cast or formed metal meter housing Damage: Medium

Safety Risk: Moderate **Priority:** Priority

'Next Action:' Paint, treat, or replace corroded pipe sections; document for insurance/inspection.

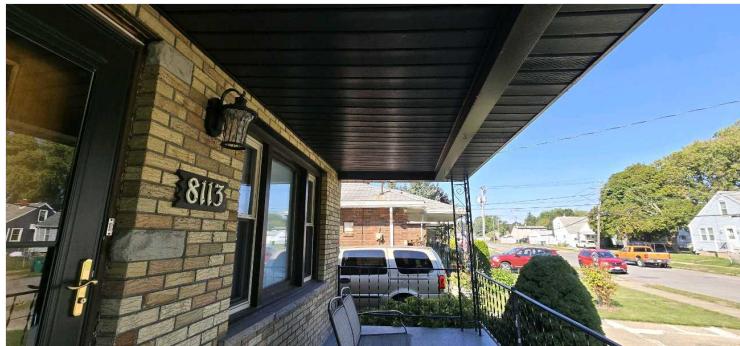
Entry Door (Condition Notes)

'Safety/Compliance:' Painted metal or composite door; surface intact, no weathering or visible damage.

'Safety/Compliance:' Finished soffit/ceiling; no visible defects, stains, or sag.

'Safety/Compliance:' Exterior wall-mounted fixture; no visible defects.

'Safety/Compliance:' All visible windows are undamaged, glass is intact, no seal failure.

'Safety/Compliance:' Metal porch railing, visually straight and secure; no obvious corrosion.

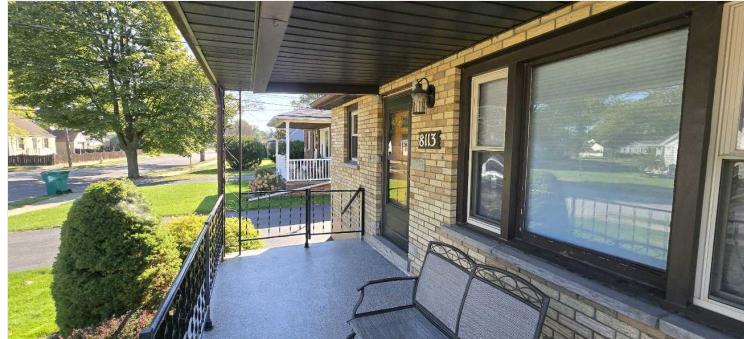
Front Door (Condition Notes)

'Marketability & Asset Impact:' Minor cosmetic paint touch-up recommended for staging and photography, otherwise satisfactory for listing and showing.

'Safety/Compliance:' Steps and railings show no major defects, just surface debris and minor dust. No structural or trip hazard noted.

'Safety/Compliance:' Textured concrete porch; no apparent damage or hazards.

'Safety/Compliance:' Wood-framed glass windows; glass is intact, frame in stable condition, minor weathering at sill.

'Marketability & Asset Impact:' Cleaning and minor touch-ups at sill recommended to enhance listing photos; otherwise, not a disclosure issue if maintained.

'Safety/Compliance:' Brick in strong visible condition, uniform mortar, no cracking or spalling.

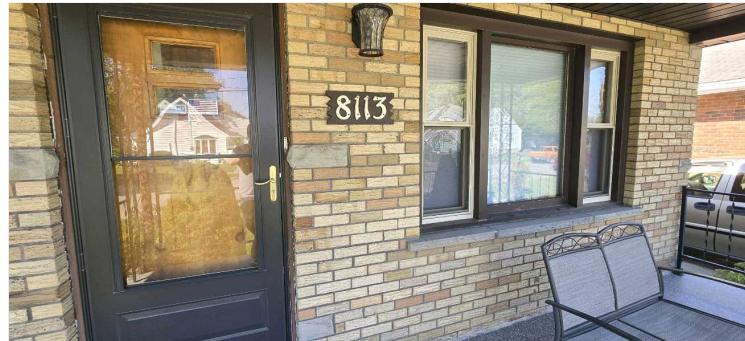
Storm Door (Condition Notes)

'Safety/Compliance:' Metal-framed storm door with glass panel; glass and frame appear intact with no visible cracks, dents, or rust. Handle and latch hardware present and aligned, frame finish consistent. No safety or code issues.

'Safety/Compliance:' Wall-mounted exterior light; fixture is solidly attached and free from visible damage or exposed wiring.

'Safety/Compliance:' Brick veneer siding with no visible cracks, missing mortar, or structural movement; mortar joints are even.

'Safety/Compliance:' Three-part window set; glass intact, painted wood trim shows minor wear and chipping at lower ledge. No safety exposure; no broken glass.

'Safety/Compliance:' Speckled concrete surface in intact condition; no tripping hazard or significant wear.

'Safety/Compliance:' Straight and secure metal railing; no rust, loose posts, or sharp edges.

'Safety/Compliance:' No cracks, missing bricks, or mortar issues seen.

'Safety/Compliance:' Painted door and hardware, no visible peeling or defects. No issues observed for insurance, listing, or buyer access.

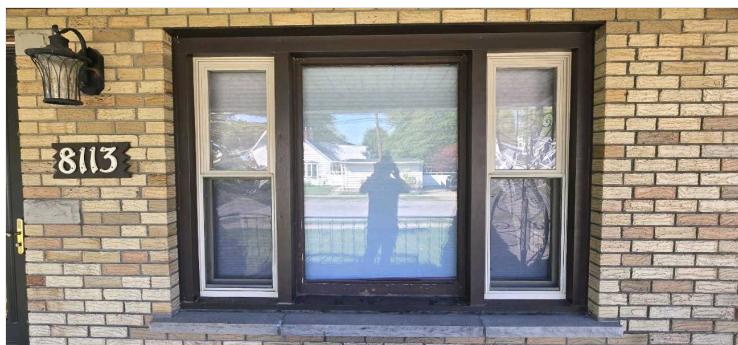
Window Unit (Condition Notes)

'Safety/Compliance:' Central fixed pane flanked by two hung windows, wood trim shows scuffs and moderate paint peeling. No visible glass defects or open gaps.

'Marketability & Asset Impact:' Condition is typical but worn trim may reduce photography impact; prepping will minimize buyer concern over upkeep.

'Safety/Compliance:' Weathered, stable, with some discoloration but no wiring exposed and no physical damage.

'Safety/Compliance:' Solid brick/mortar, no deterioration or moisture marks noted.

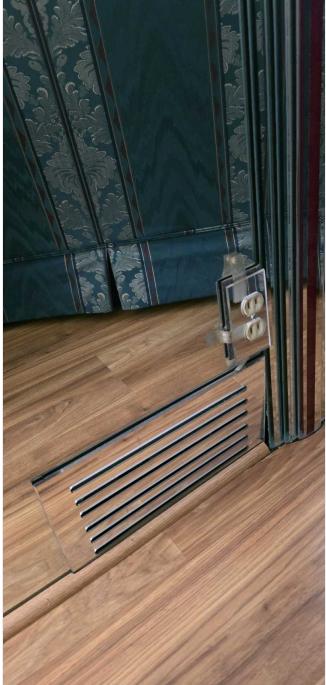
Electrical Outlet (Key Disclosures)

Safety/Compliance: Outlet mounted at floor level in mirrored wall panel; cover is secure but placement may increase risk for accidental contact, especially for children or cleaning. Potential inspection/code focus.

Marketability & Asset Impact: If code-acceptable, present as is, but potential for inspection-related ask or minor buyer concern. Disclosure is recommended for transparency and insurance coverage.
